MATERIAL FINDINGS AND RECOMMENDATIONS:

INSPECTOR SUMMARY OF MILESTONE PHASE 1 INSPECTION

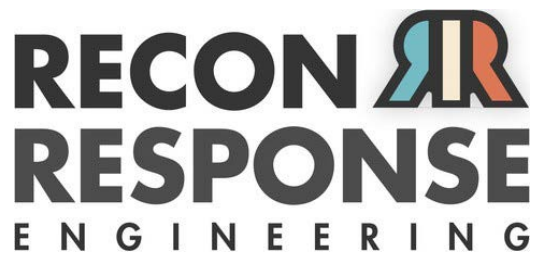
“Substantial structural deterioration” is defined in Florida Statute 553.899 as substantial structural distress that negatively affects a building’s general structural condition and integrity. The term does not include surface imperfections such as cracks, distortion, sagging, deflections, misalignment, signs of leakage, or peeling of finishes unless the inspector determines that such surface imperfections are a sign of substantial structural deterioration

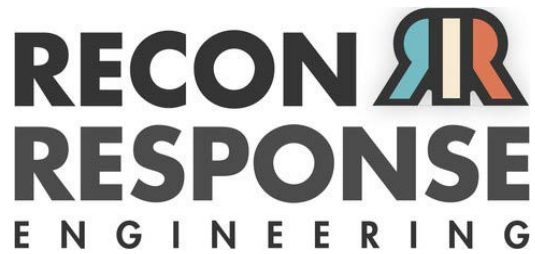
- 4) State whether unsafe or dangerous conditions, as those terms are defined in the Florida Building Code, were observed.
- 5) Recommend any remedial or preventive repair for any items that are damaged but are not substantial structural deterioration.
- 6) Identify and describe any items requiring further inspection.

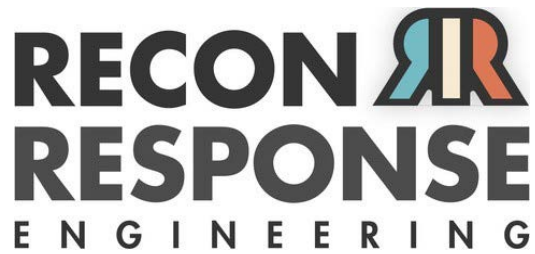
WHAT THE ASSOCIATION MUST DO WITH THIS INFORMATION

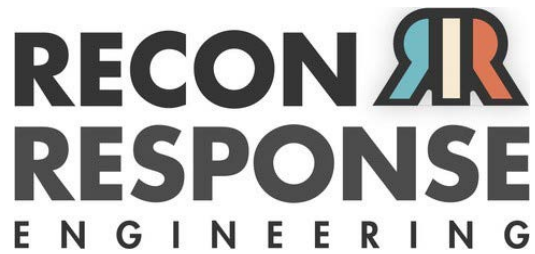
- 1) Pinellas County Property Appraiser Records
- 2) Pinellas County Construction Permit Records

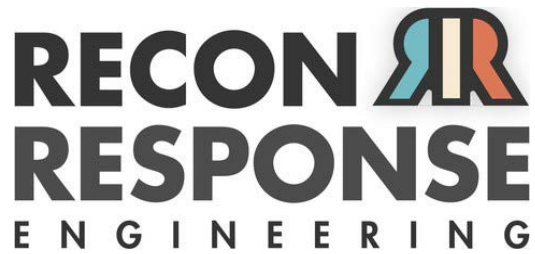
Required Item 5 of 6: *Recommend any remedial or preventive repair for any items that are damaged but are not substantial structural deterioration.*

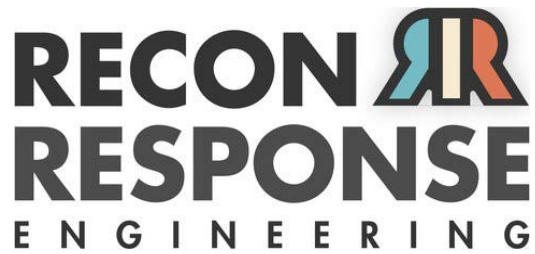
THIS SECTION IS A SUMMARY
REVIEW PHOTO APPENDIX FOR COMPLETE PHOTOS AND OBSERVATIONS.

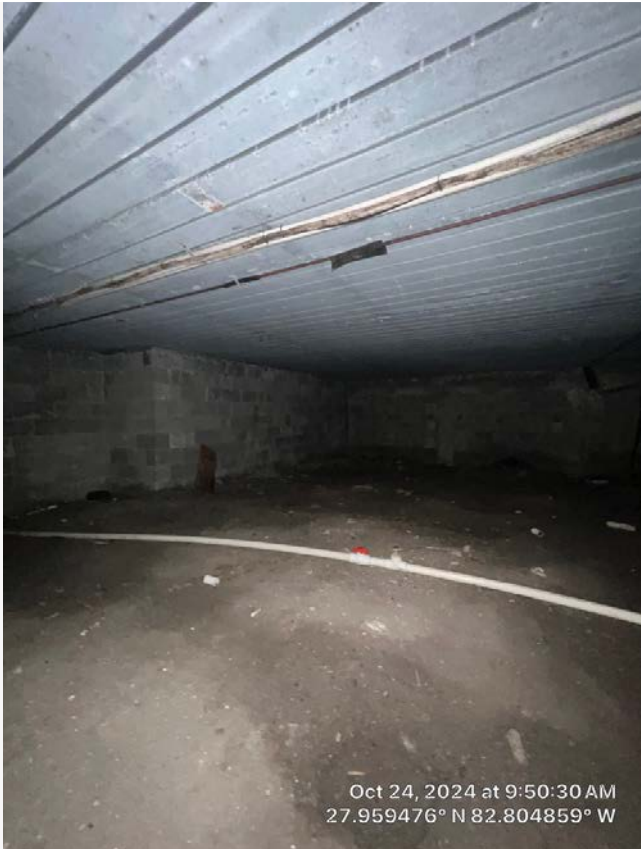
Crawl space under building. No issues observed.

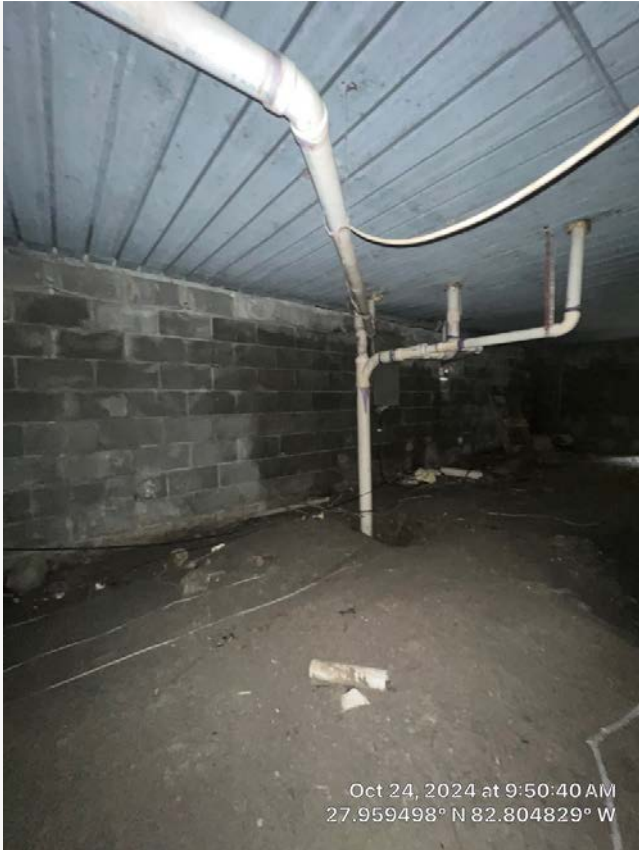
Crawl space under building. No issues observed.

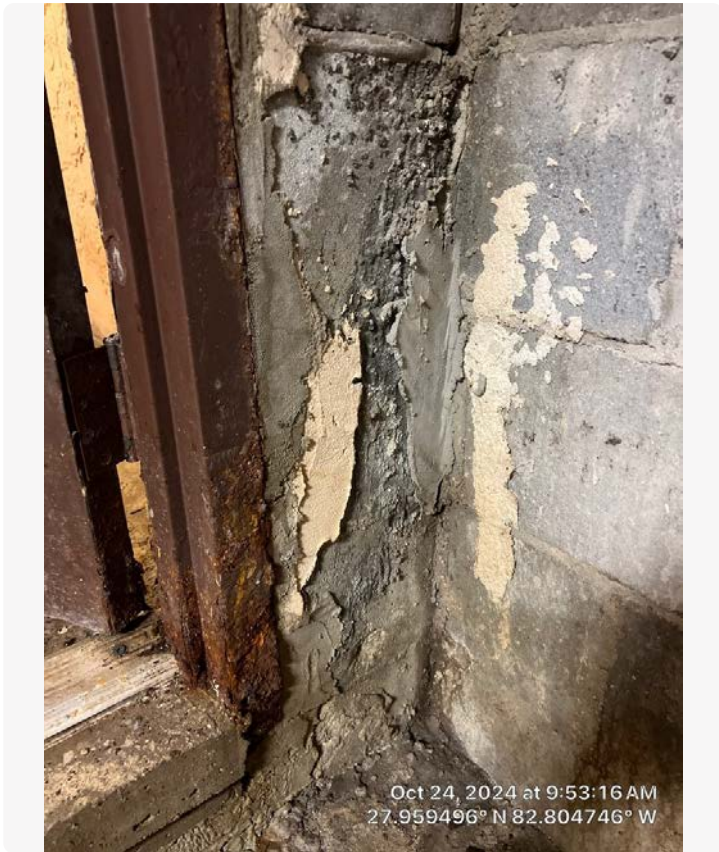
Corrosion and concrete damage noted at the door surround location in the elevator room. Long-term water intrusion is evident at this location.

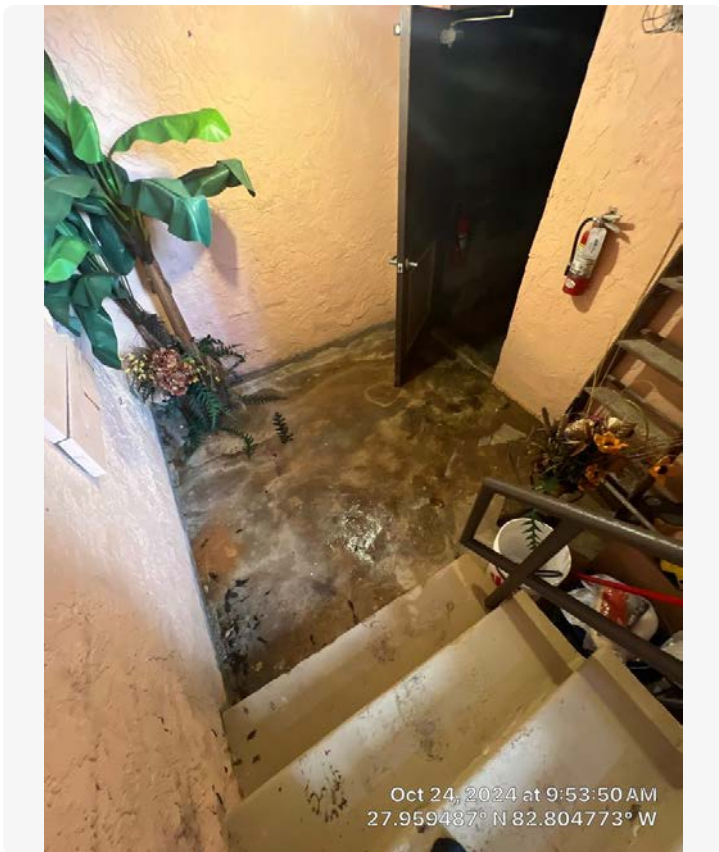
Standing water observed outside elevator room.

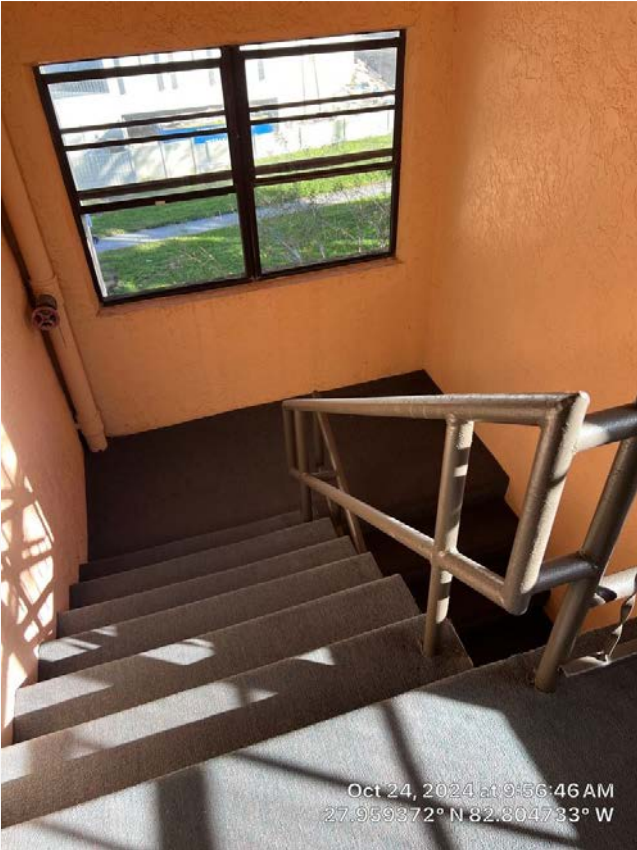
Front stairwell. Typical of conditions observed throughout the building. Handrails in this stairwell are all securely attached.

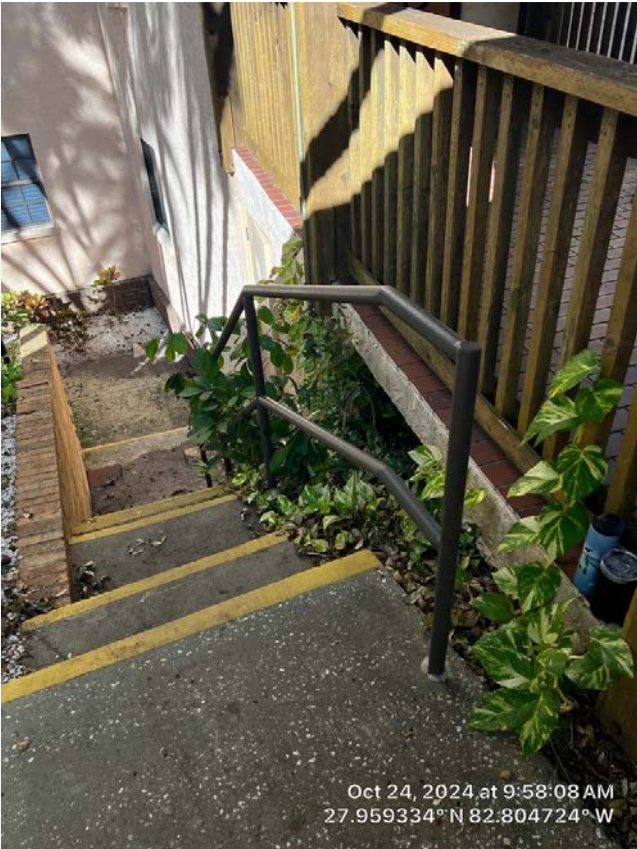
LIFE SAFETY ISSUE. Railing outside front entrance. This handrail is extremely loose and should be repaired immediately.

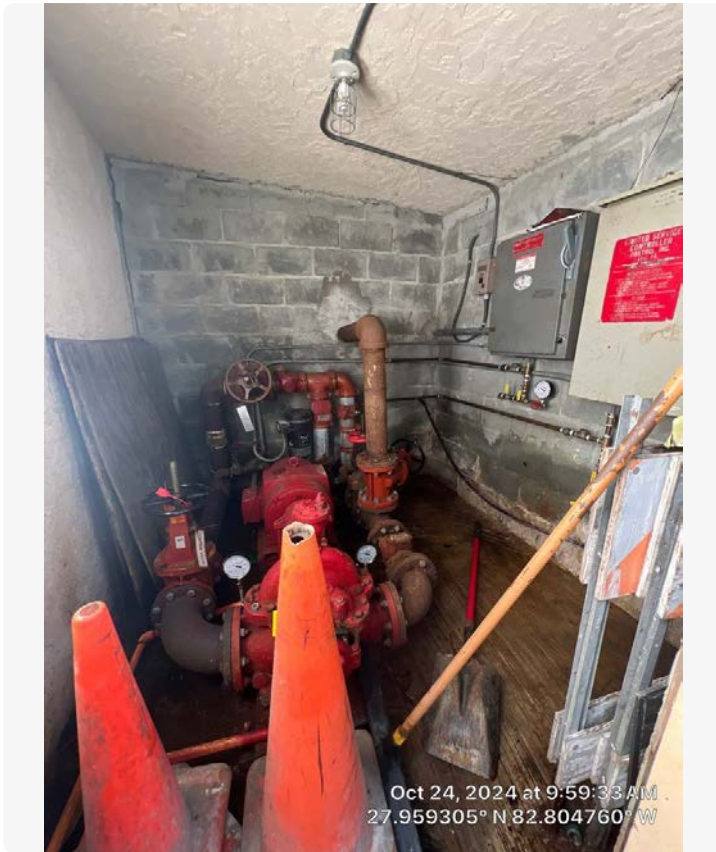
Pump room on southwestern corner of building. Resident indicated the floor at this location is always wet.

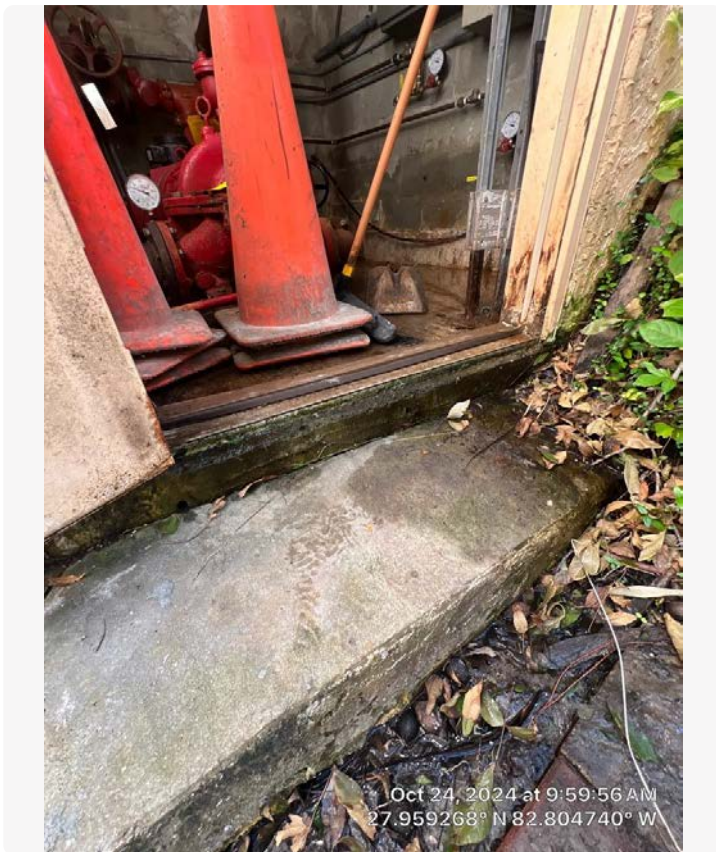
Pump room entrance. Water intrusion is obvious and the doorframe is showing signs of severe corrosion.

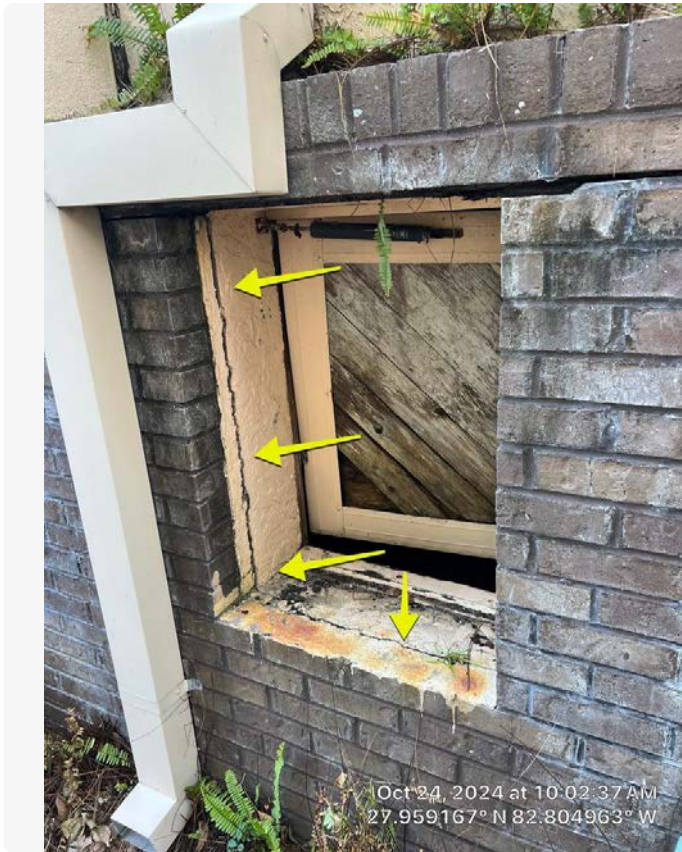
South elevation crawl space door. A large crack was observed between the building facade and the underlying concrete. This should be repaired to prevent additional water intrusion and degradation of the facade.

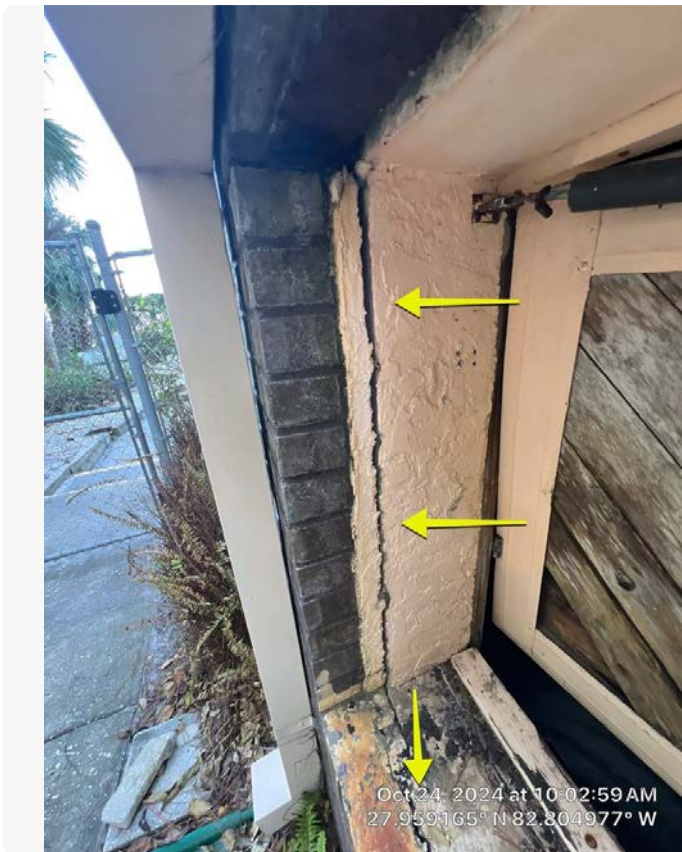
South elevation crawl space door. A large crack was observed between the building facade and the underlying concrete. This should be repaired to prevent additional water intrusion and degradation of the facade.

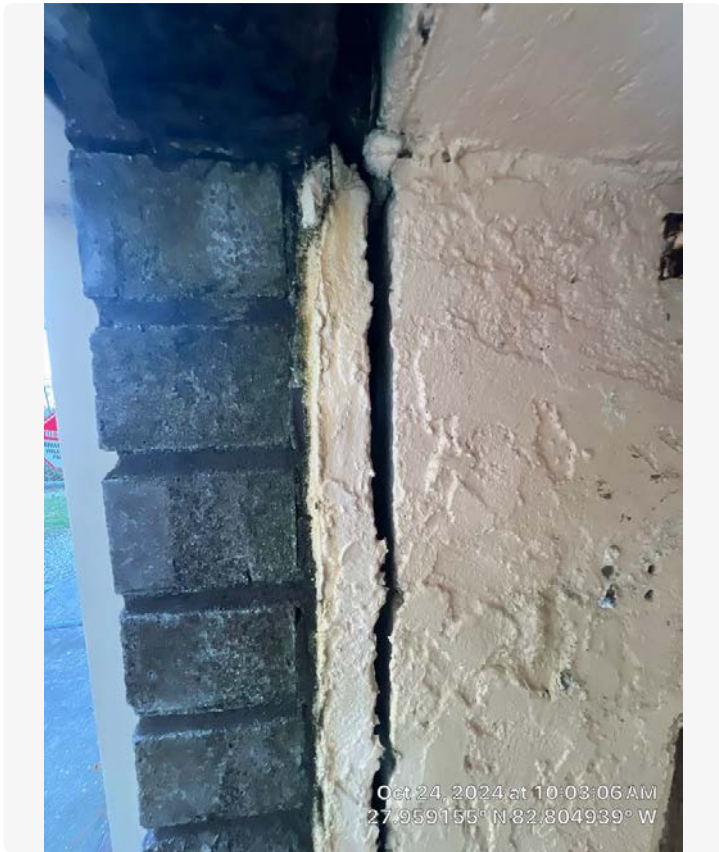
South elevation crawl space door. A large crack was observed between the building facade and the underlying concrete. This should be repaired to prevent additional water intrusion and degradation of the facade.

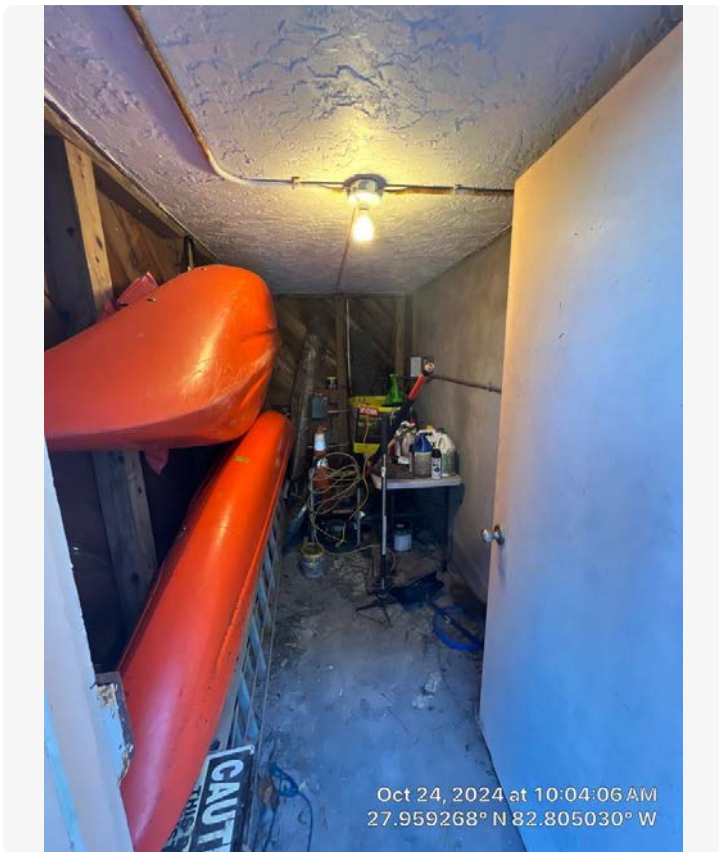
Storage room southwest elevation. No adverse conditions observed at this location.

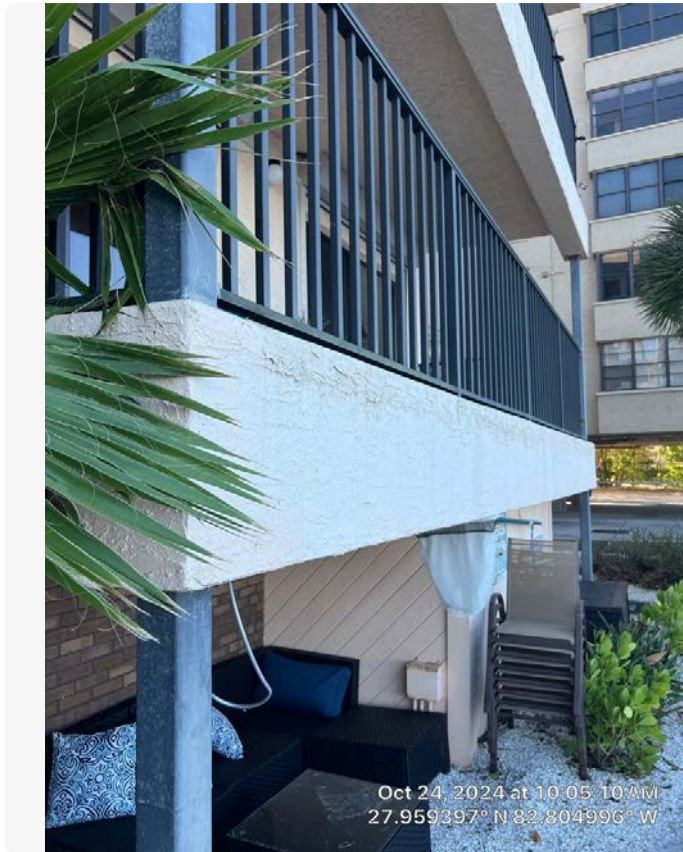
West elevation first floor slab edge.

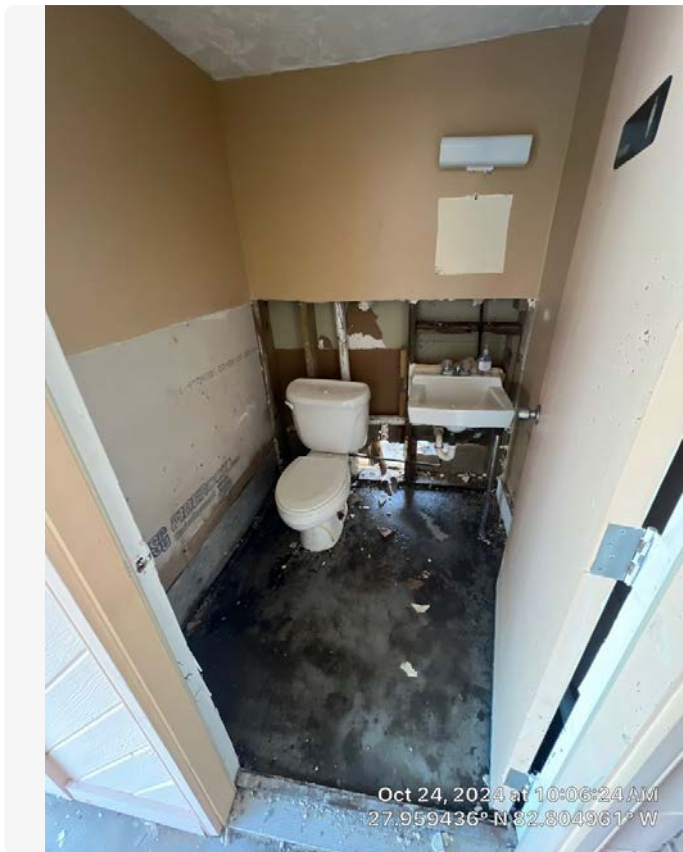
West elevation ladies room. Damage is as result of Hurricane Milton.

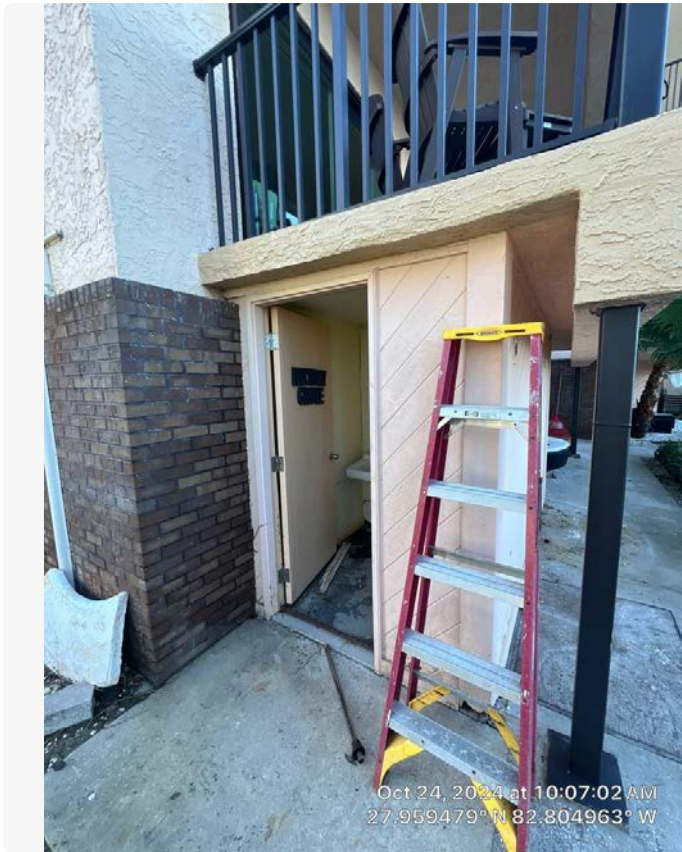
Northwest elevation mens room.

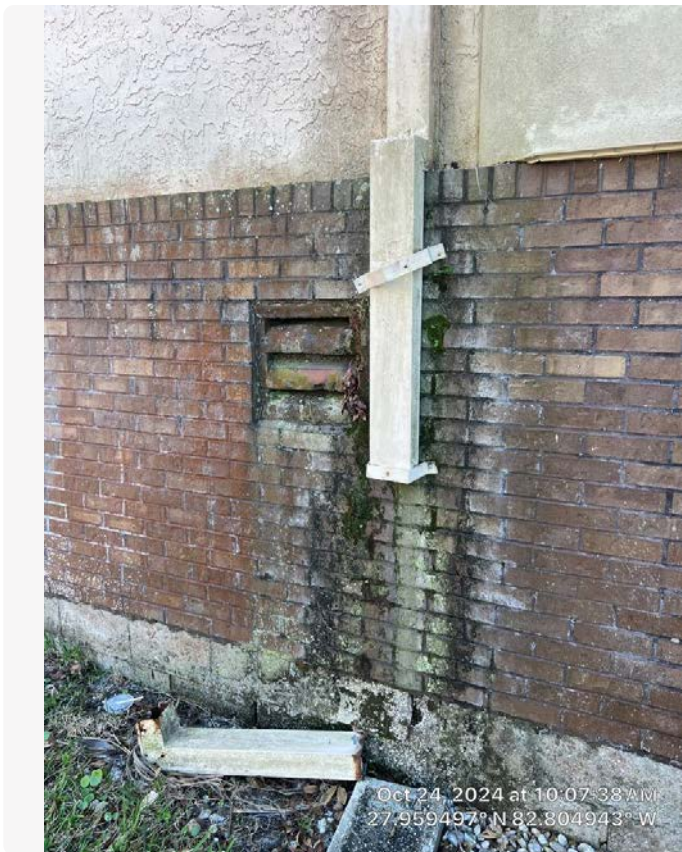
North elevation. Drain appears to be causing mold and water penetrations into the brick facade at this location. The brick facade is in poor condition and requires repair.

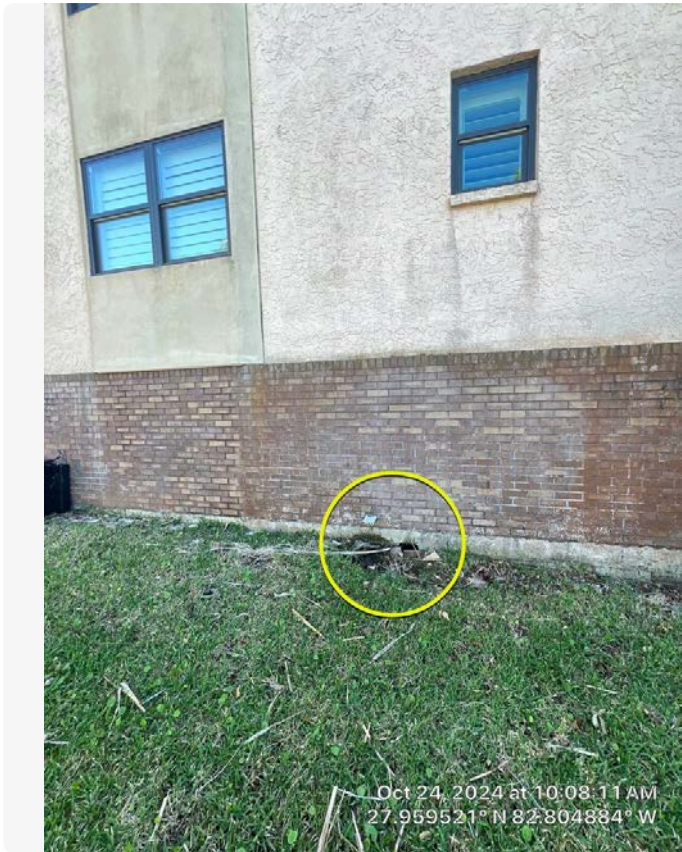
North elevation. Building penetration and possible water intrusion observed at this location. This will eventually result in soil displacement or erosion of foundations at the crawlspace behind the wall.

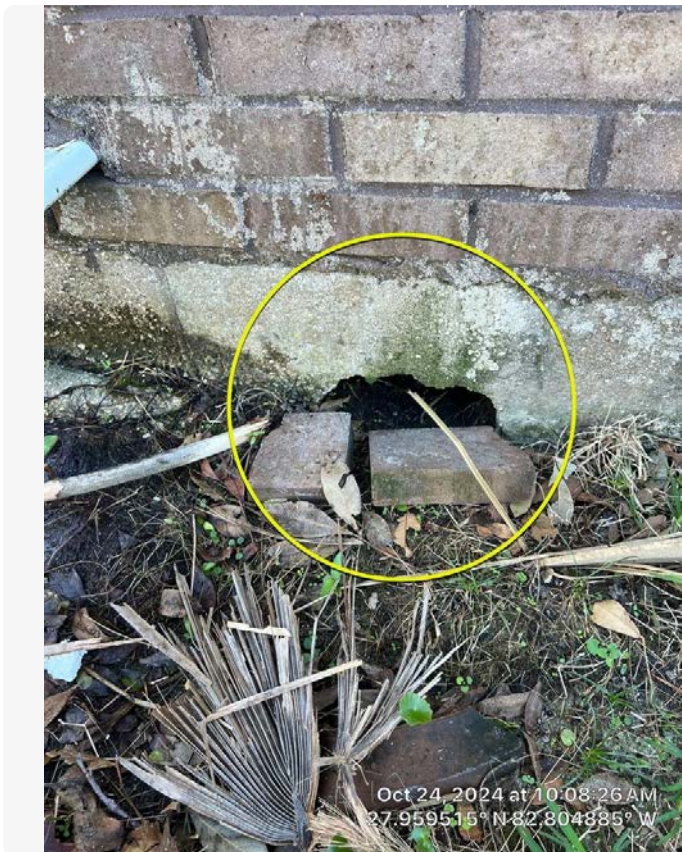
North elevation. Building penetration and possible water intrusion observed at this location. This will eventually result in soil displacement or erosion of foundations at the crawlspace behind the wall.

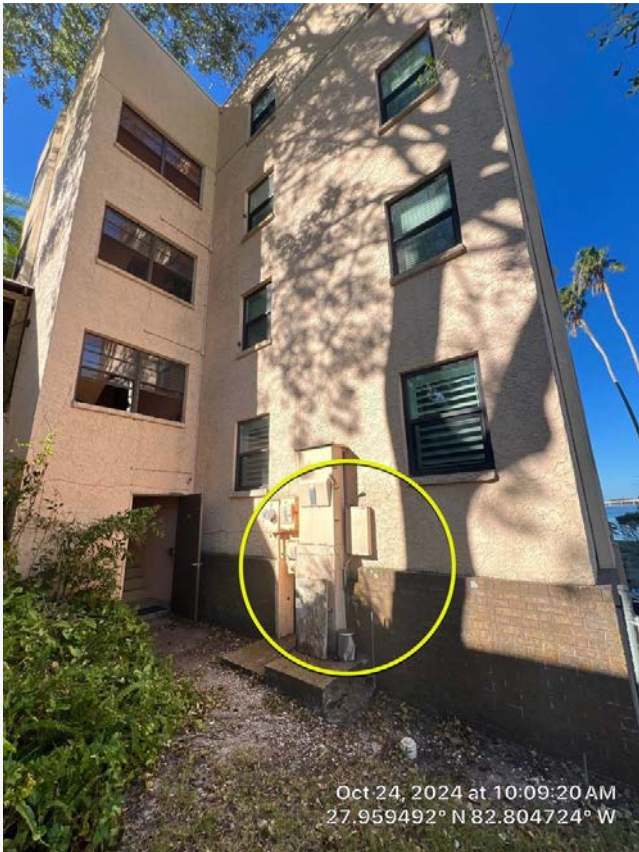
Front east elevation. Cracking in stucco observed. This crack should be repaired to prevent moisture-induced deterioration of the stucco.

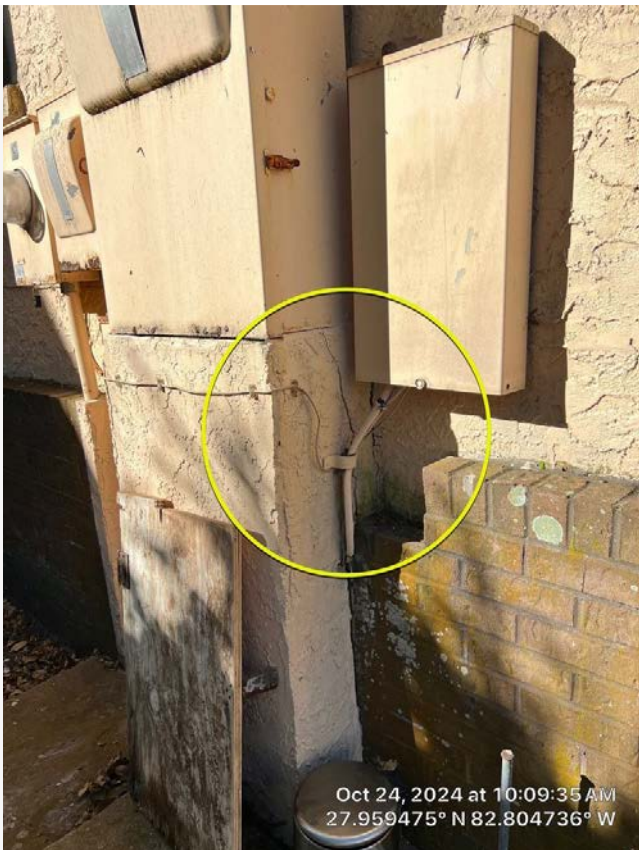
Front east elevation. Cracking in stucco observed. This crack should be repaired to prevent moisture-induced deterioration of the stucco.

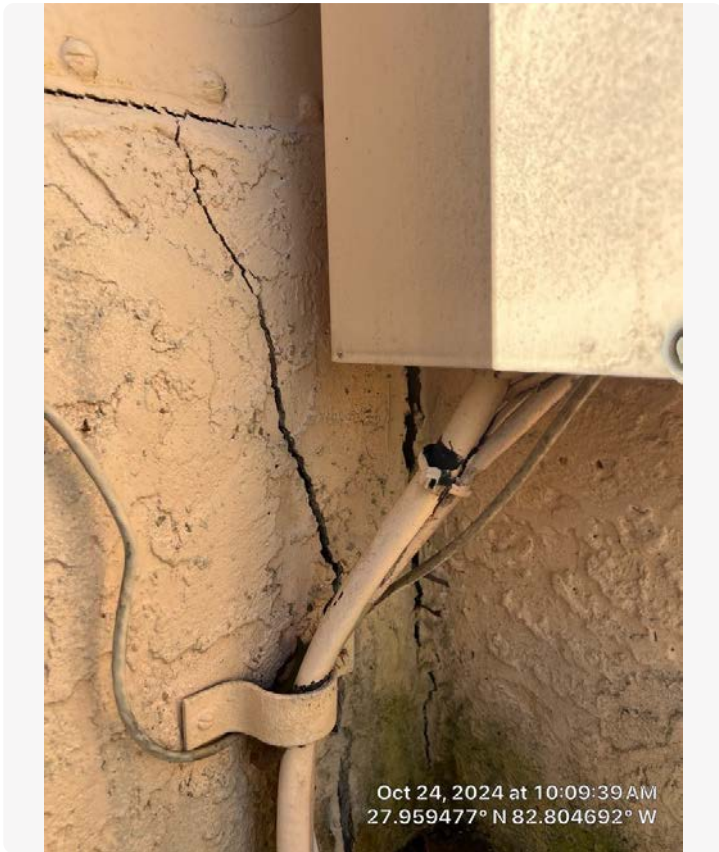
Front east elevation. Cracking in stucco observed. This crack should be repaired to prevent moisture-induced deterioration of the stucco.

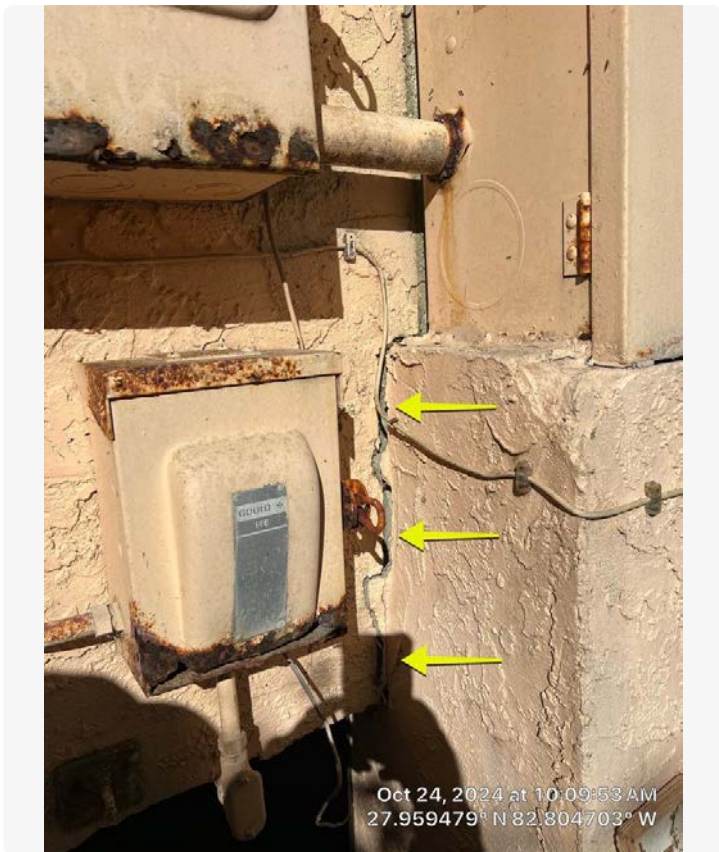
Front east elevation. Cracking in stucco and block wall observed at joint. This should be repaired to prevent additional water intrusion and degradation of the exterior envelope. Additionally, exterior electrical component housings are in poor condition due to long-term corrosion. These housings need to be replaced.

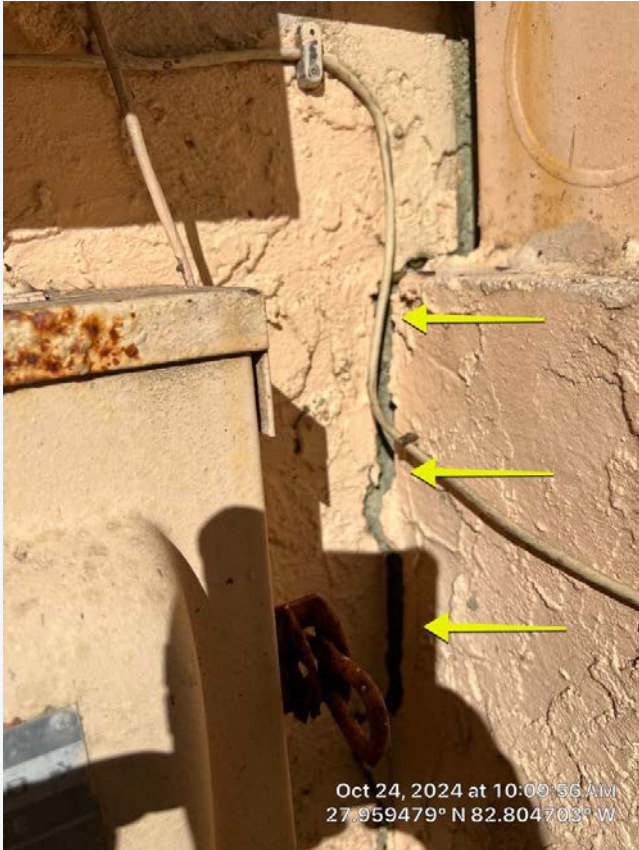
Front east elevation. Cracking in concrete observed.

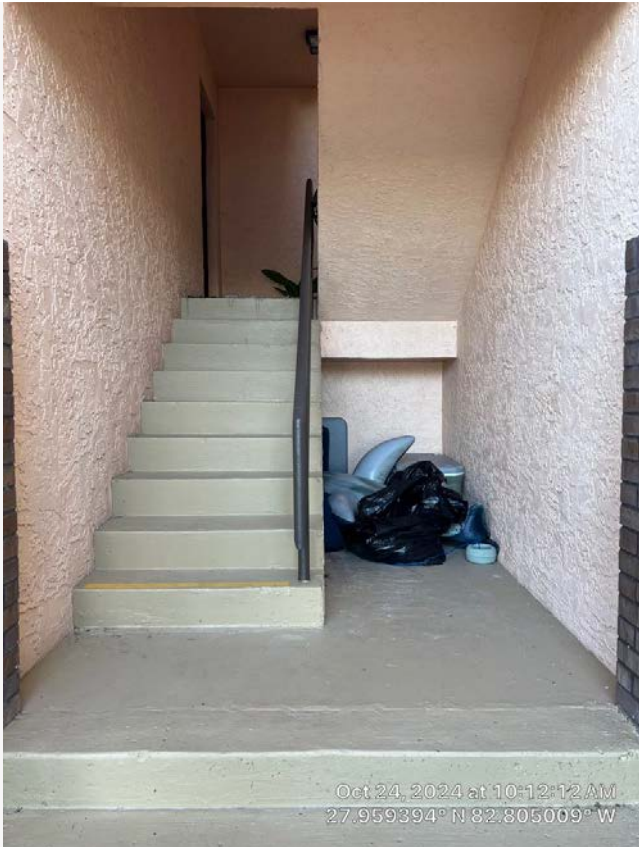
West rear stairwell.

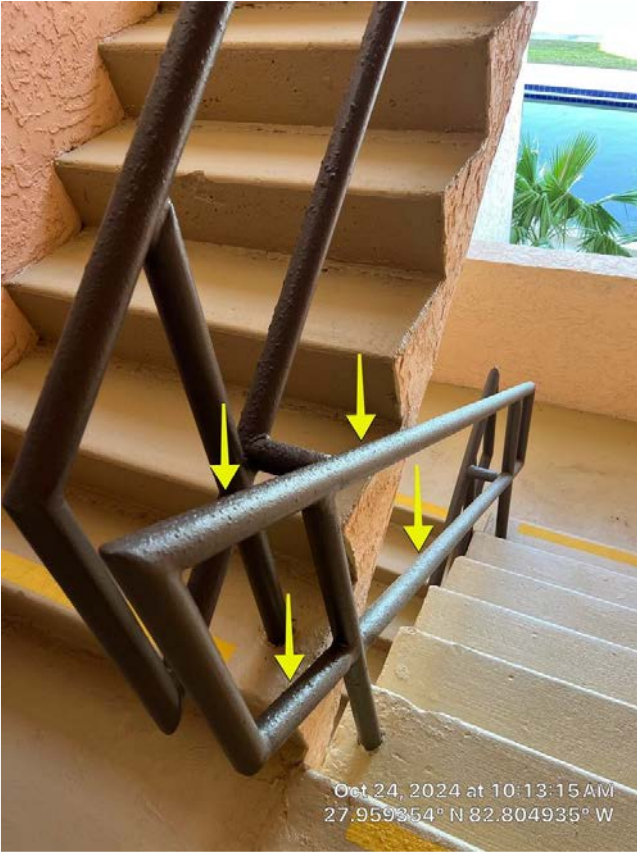
Corrosion observed on railing up to second floor. This is primarily surface rust at this time and does not appear to impact the structural integrity of the railings. However, the coatings should be maintained to improve the expected useful life of these components.

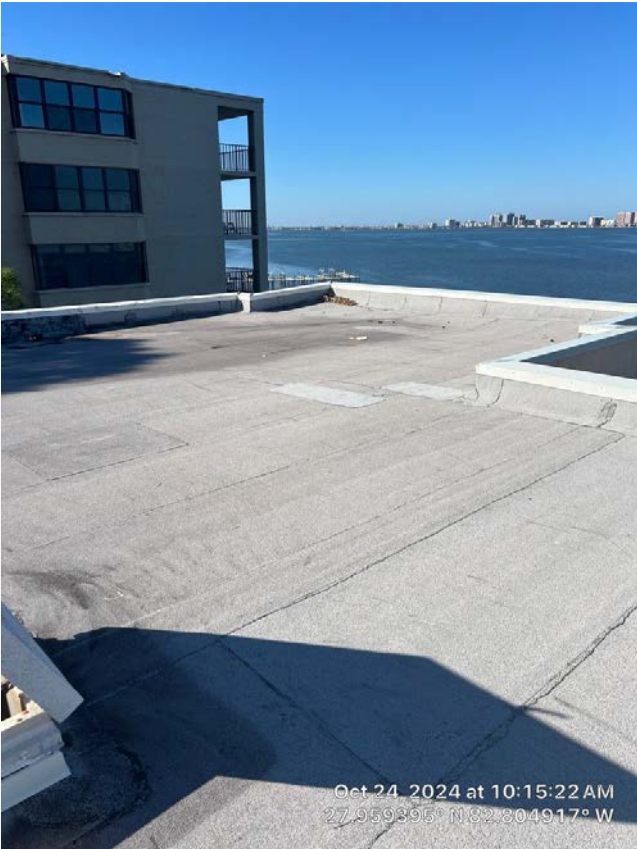
Roof view looking to southwest. Modified Bitumen (Mod Bit) roof reported to be approximately 10 years old. No leaks at current time.

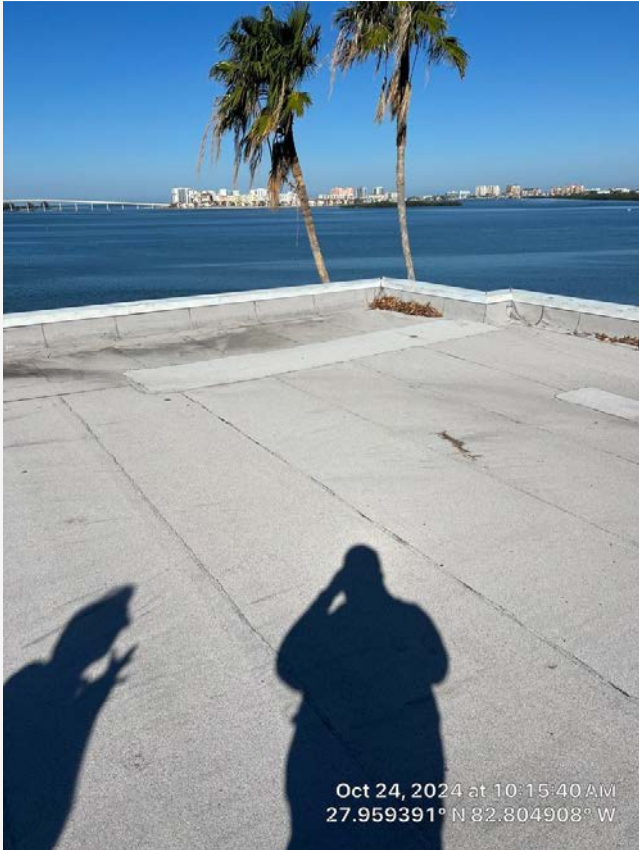
Roof view looking to the northwest.

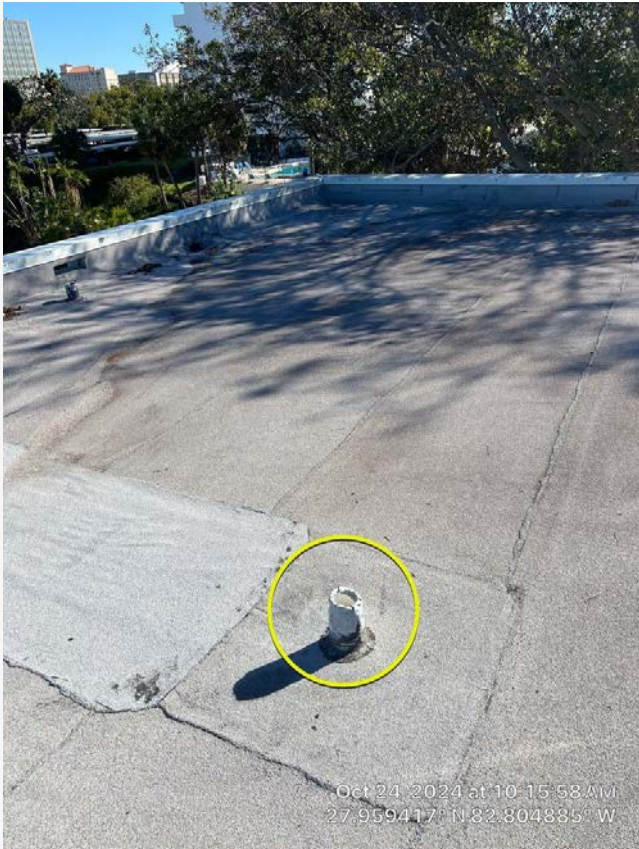
Vents appear to be in good condition and free of debris.

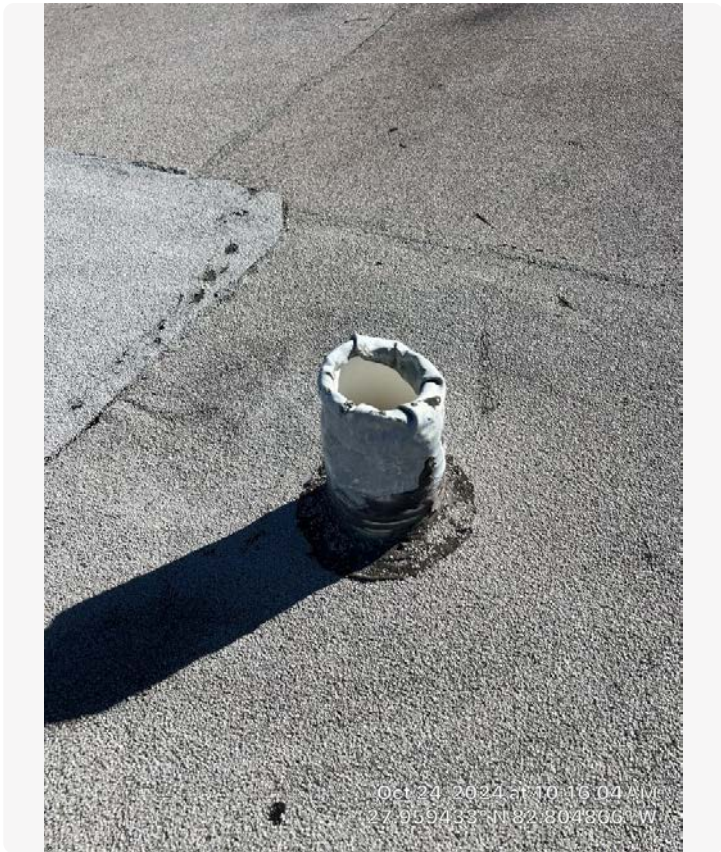
Vents appear to be in good condition and free of debris.

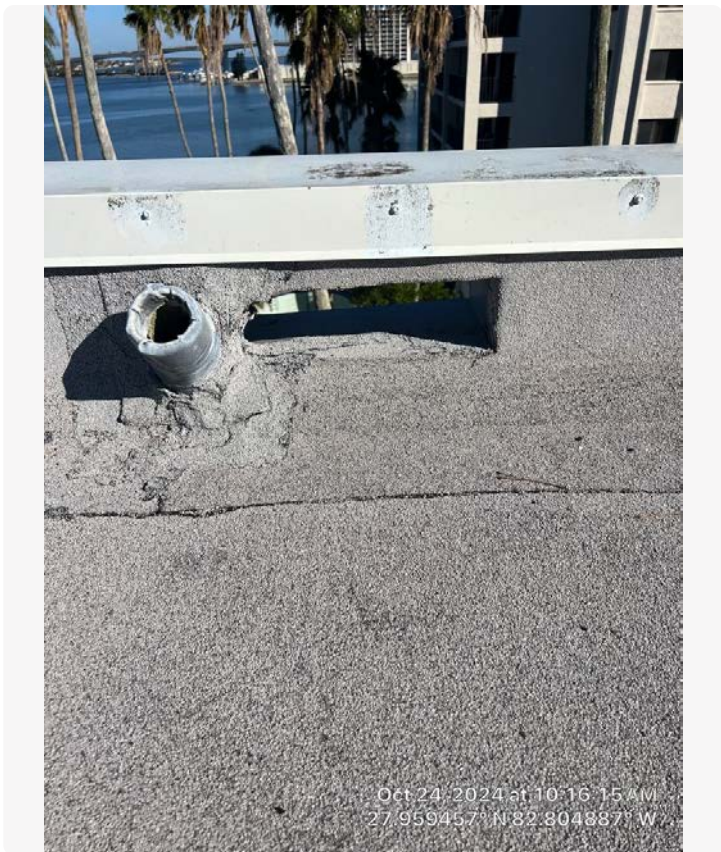
Vents and soffits are in good condition and free of debris.

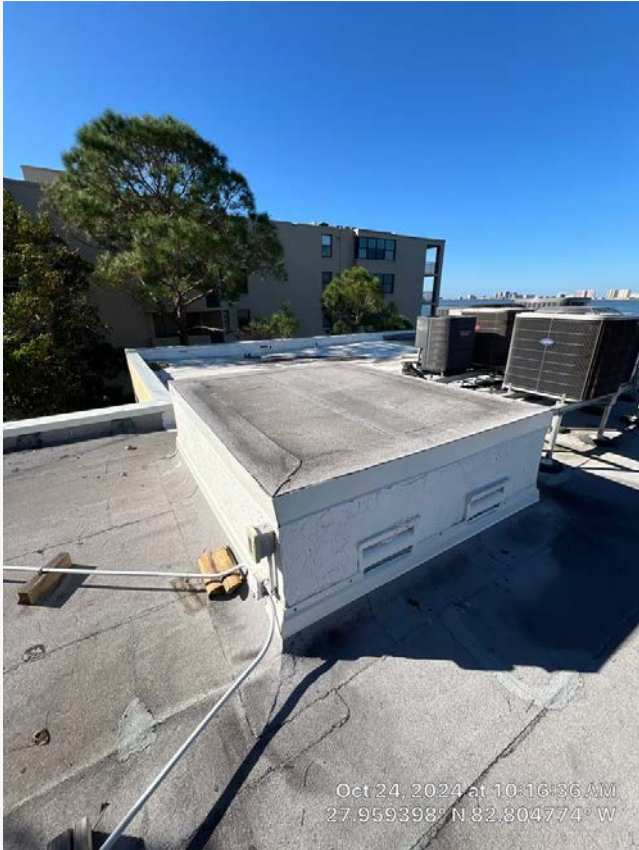
Small secondary roof on west side of roof. No adverse conditions observed.

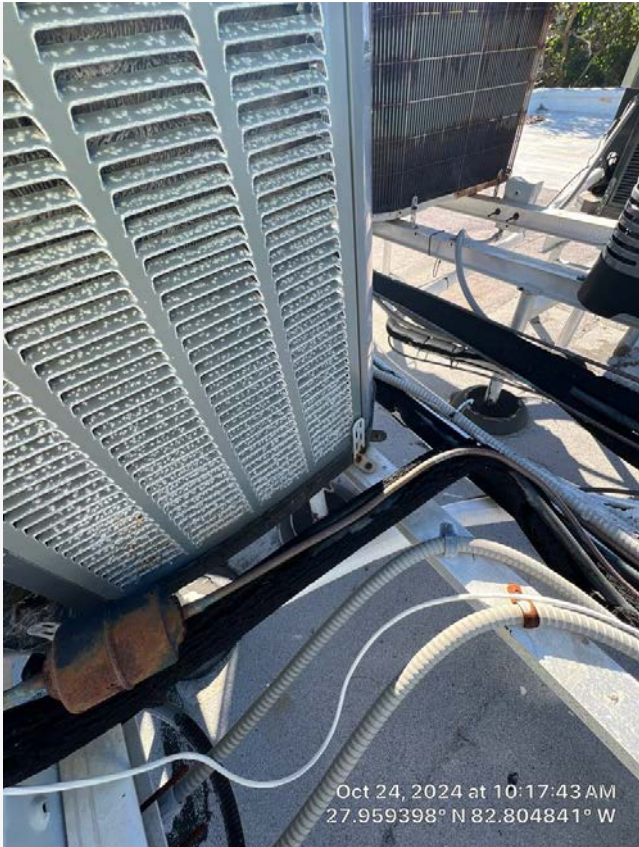
Minor corrosion observed. Typical of all hurricane straps. No action required.

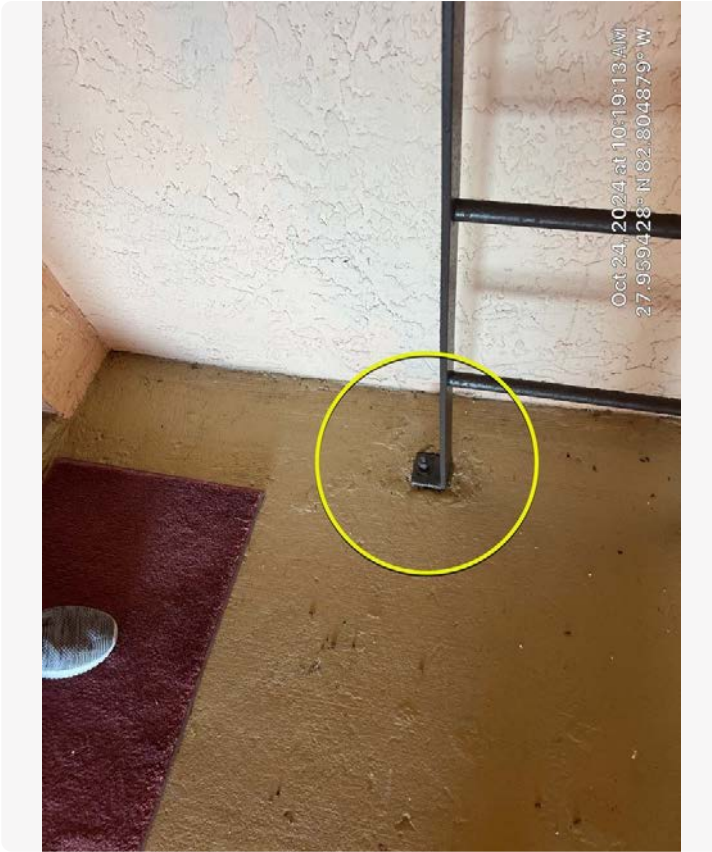
Fastener is loose at base of ladder up to roof. This needs to be reattached to ensure that ladder remains solidly connected.

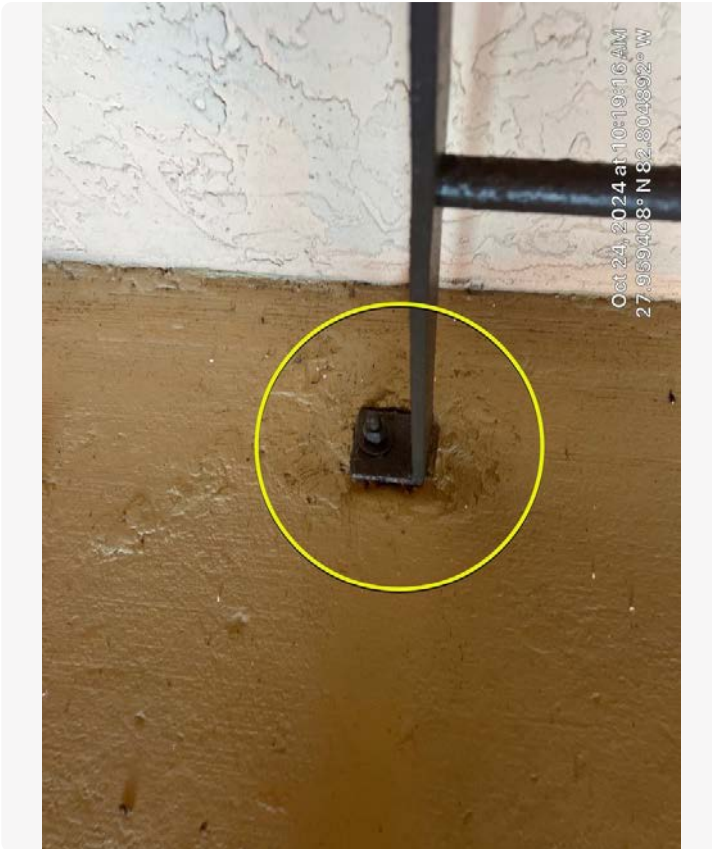
Fastener is loose at base of ladder up to roof. This needs to be reattached to ensure that ladder remains solidly connected.

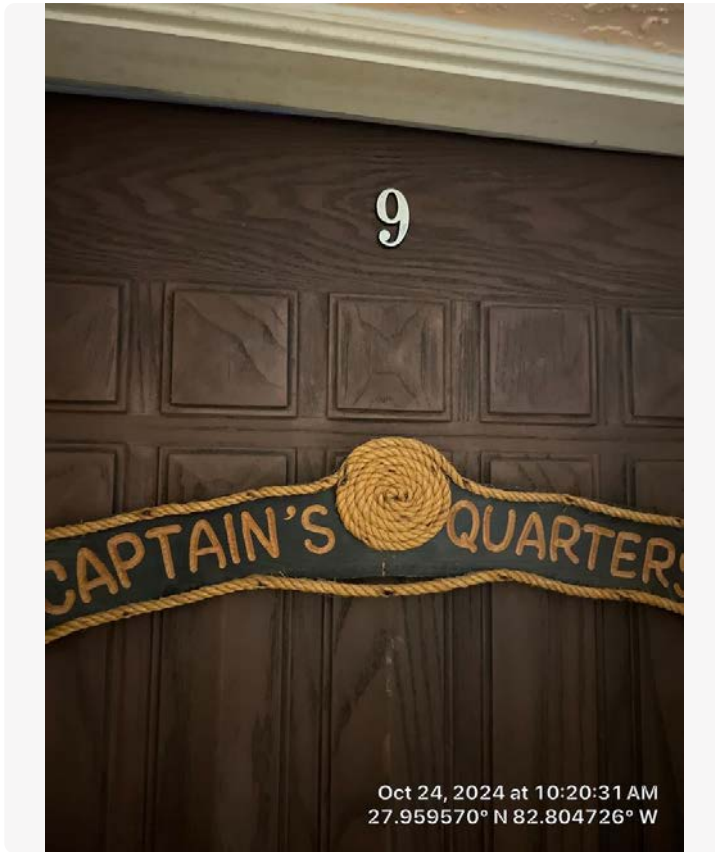
Project: Hickory Grove, Plus Attached Property
Date: 10/24/2024, 10:19am
Creator: Field Tech #1

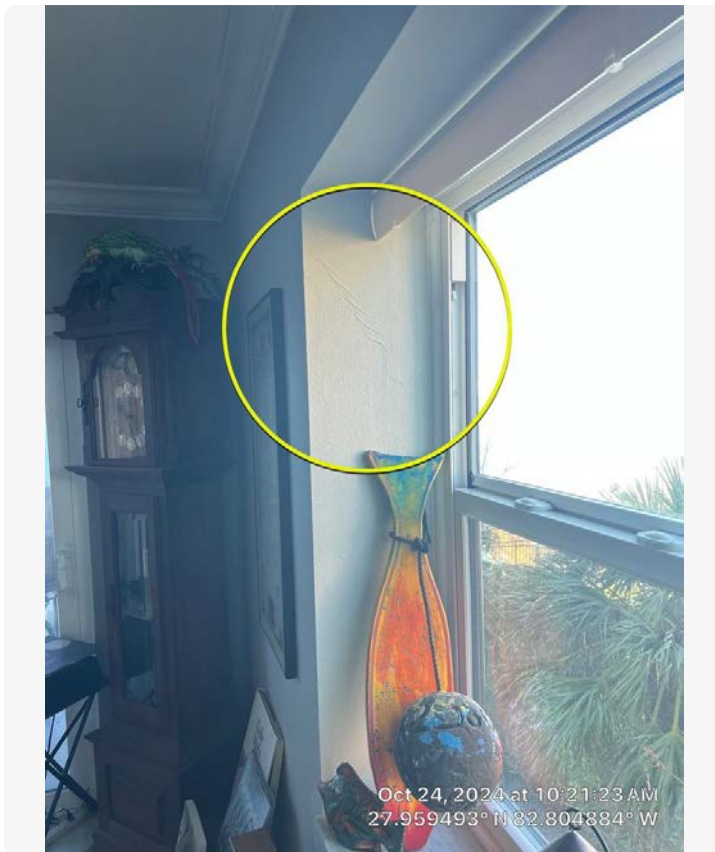
Water intrusion damage on north window in Unit 9.
