MATERIAL FINDINGS AND RECOMMENDATIONS:

INSPECTOR SUMMARY OF MILESTONE PHASE 1 INSPECTION

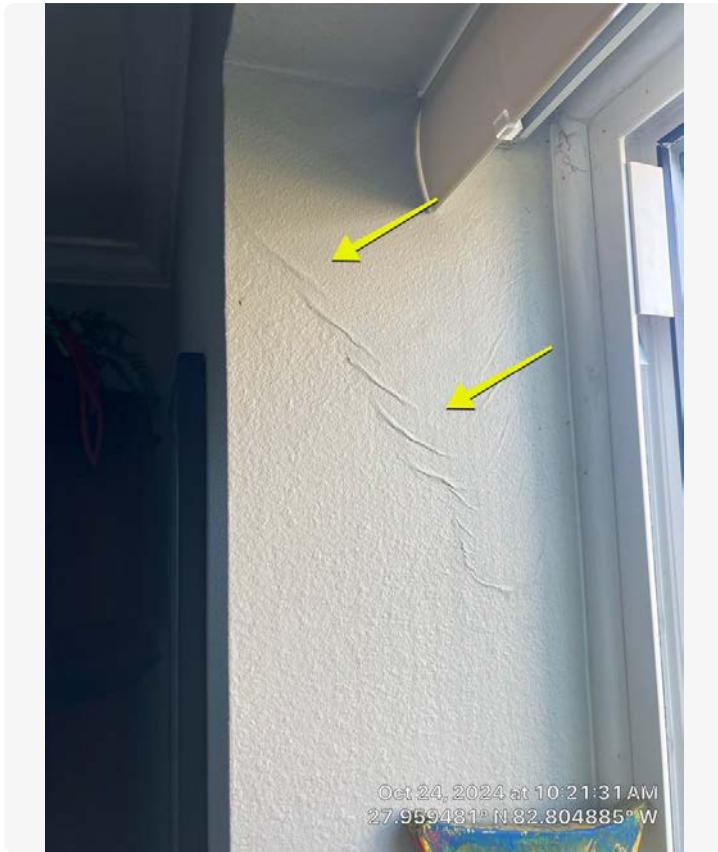
Water intrusion damage on north window in Unit 9.

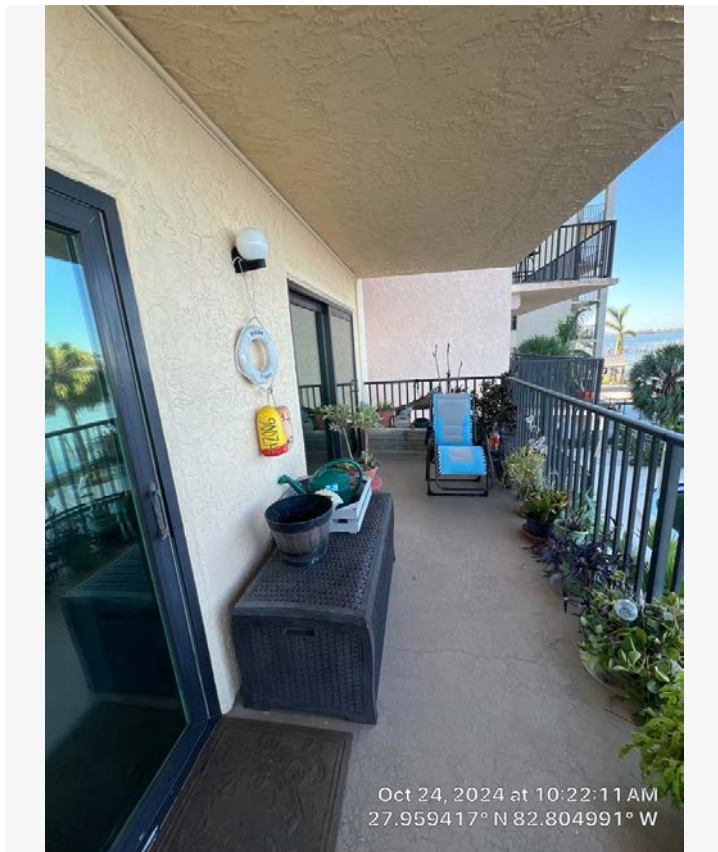
Balcony view Unit 9.

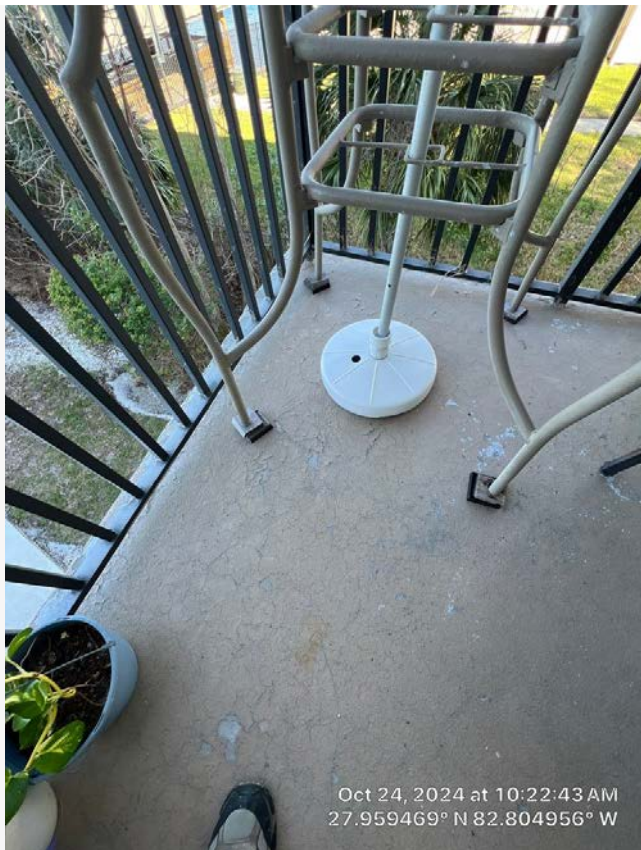
Unit 9 balcony. Waterproofing has reached the end of its useful life and should be replaced.

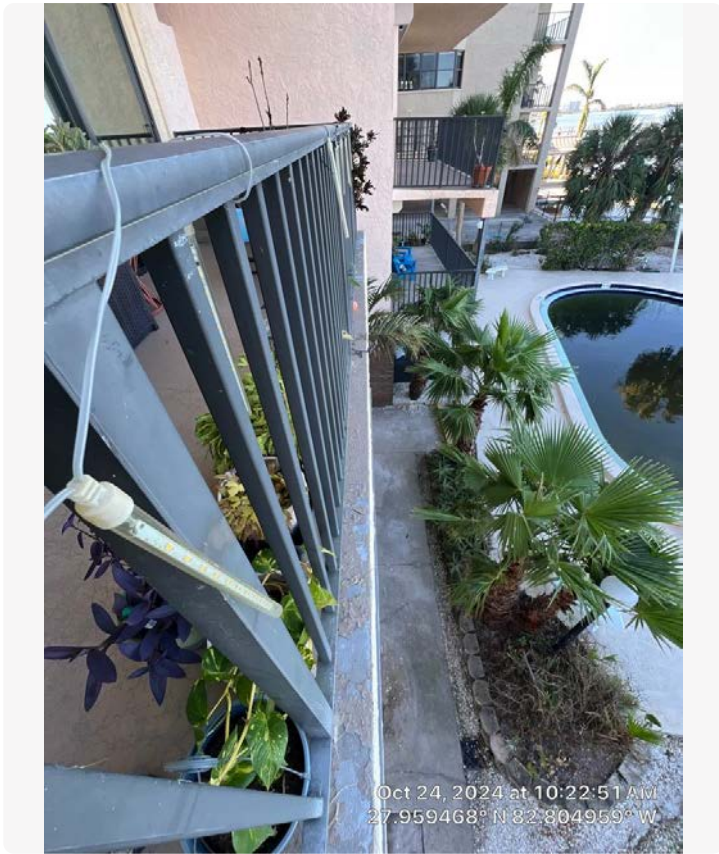
Deteriorating coatings on slab edge on Unit 9 balcony. This balcony needs to be stripped down to bare concrete and then recoated.

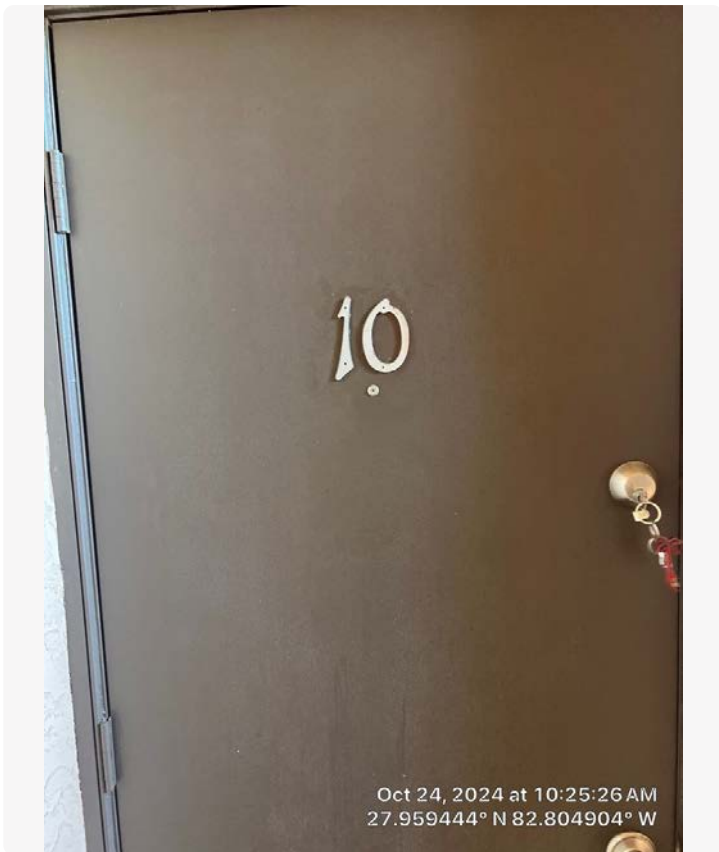
Project: Hickory Grove, Plus Attached Property
Date: 10/24/2024, 10:22am
Creator: Field Tech #1

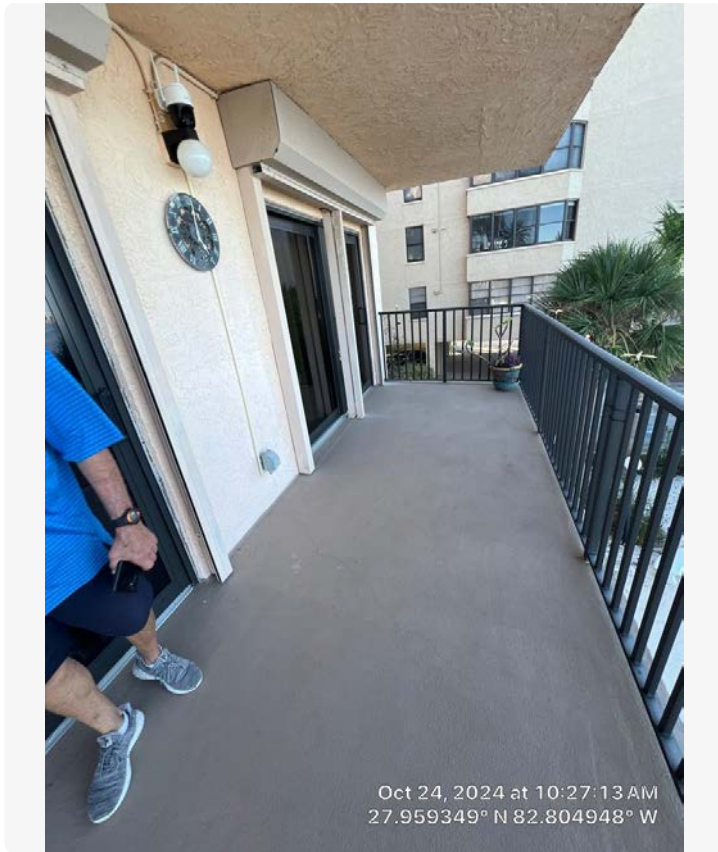
Unit 10 Balcony general conditions.

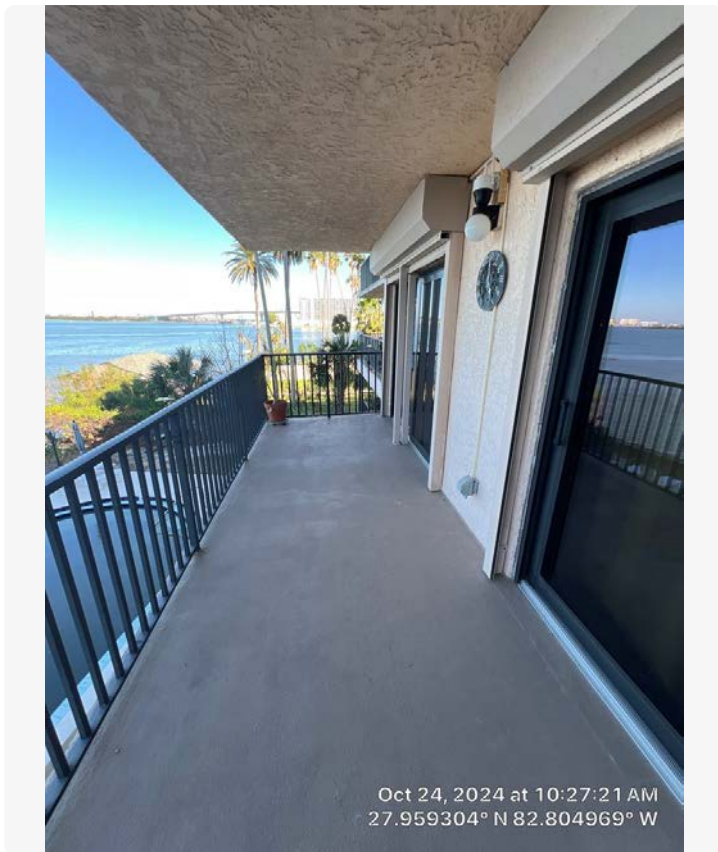
Alternate view of the balcony for Unit 10.

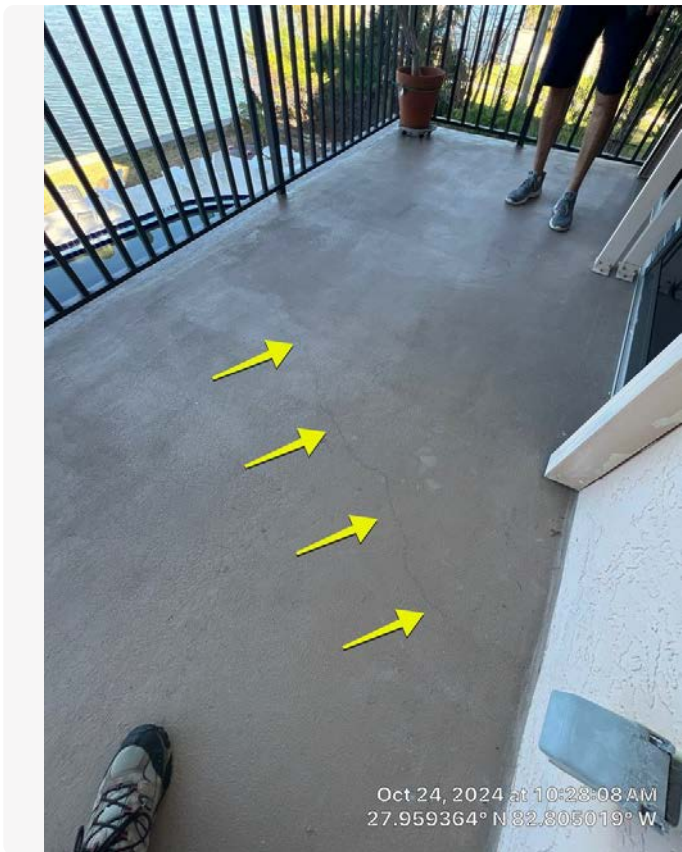
Minor crack observed on balcony for Unit 10. This is not a structural issue and no action is required, however the deck should be coated with a waterproof membrane which will bridge this crack and prevent water intrusion into the slab.

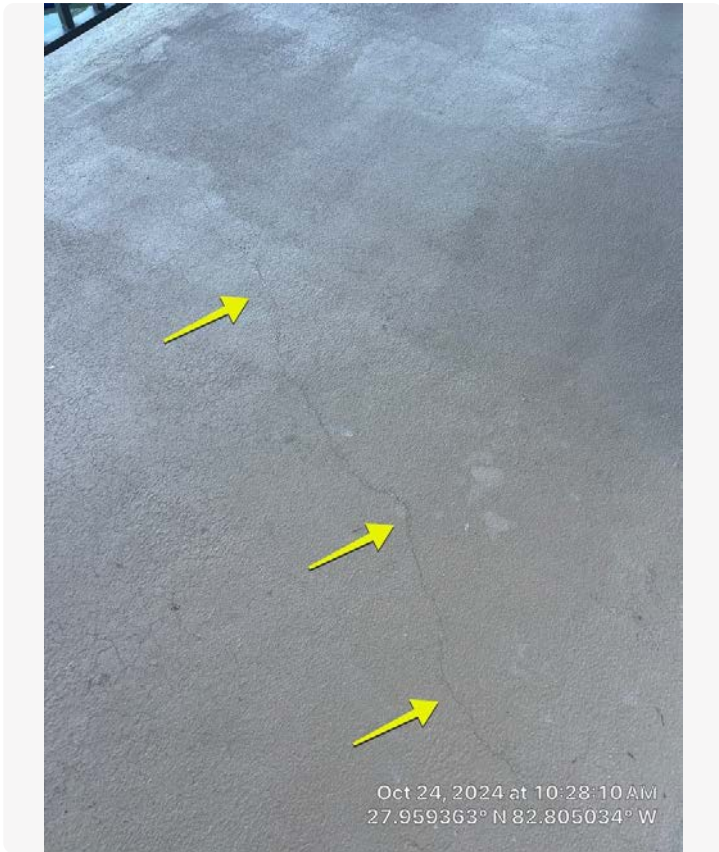
Minor crack observed on balcony for Unit 10. This is not a structural issue and no action is required, however the deck should be coated with a waterproof membrane which will bridge this crack and prevent water intrusion into the slab.

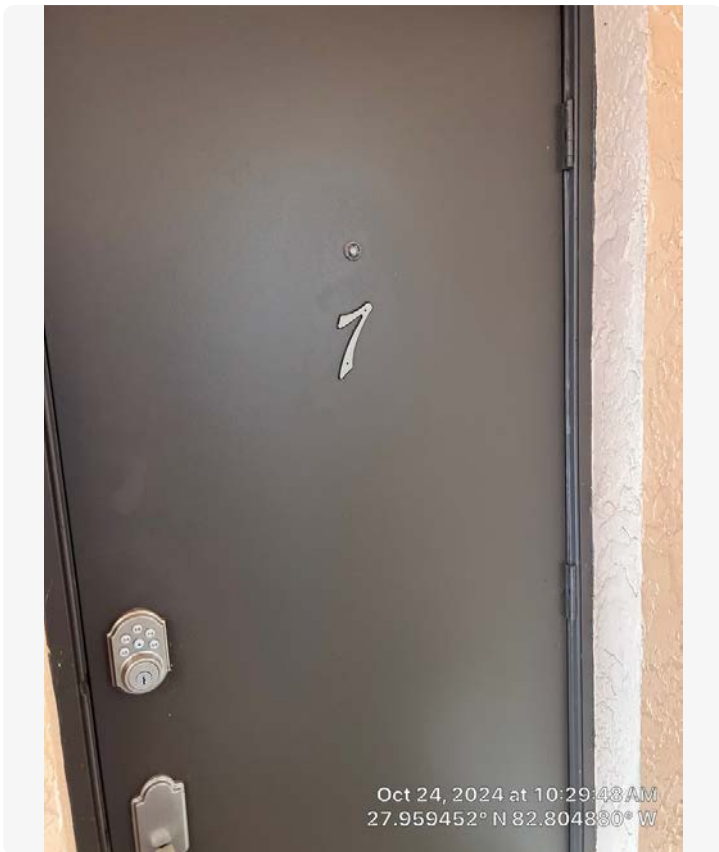
Project: Hickory Grove, Plus Attached Property
Date: 10/24/2024, 10:28am
Creator: Field Tech #1

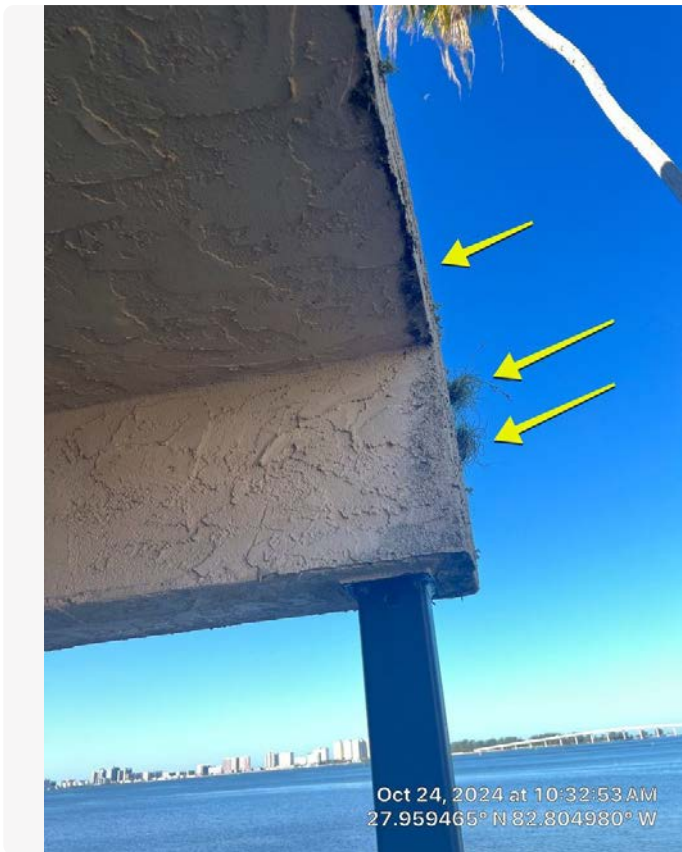
Unit 7 balcony roof. Moisture and plant life observed at this location.

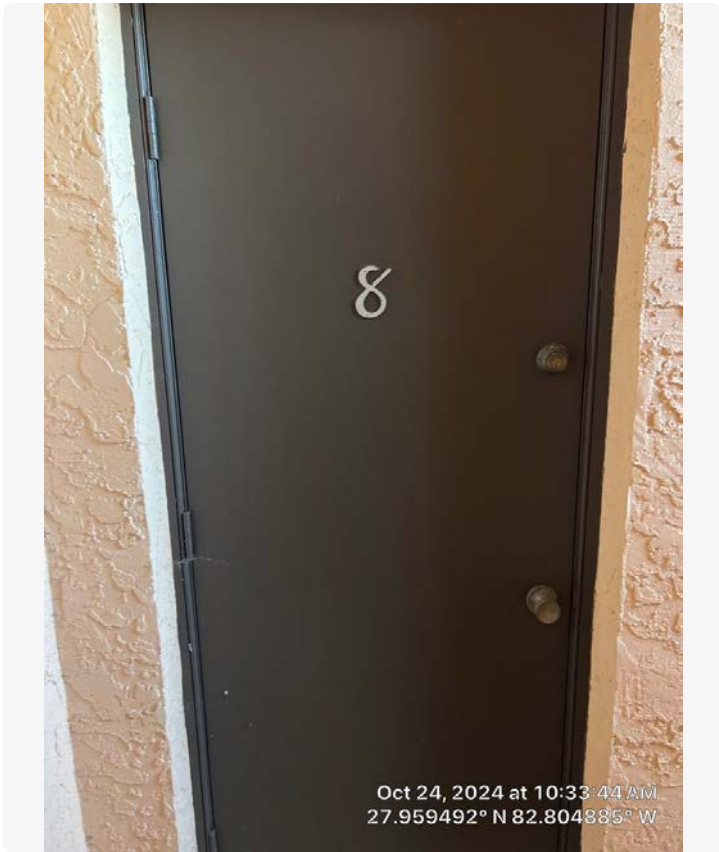
Project: Hickory Grove, Plus Attached Property
Date: 10/24/2024, 10:32am
Creator: Field Tech #1

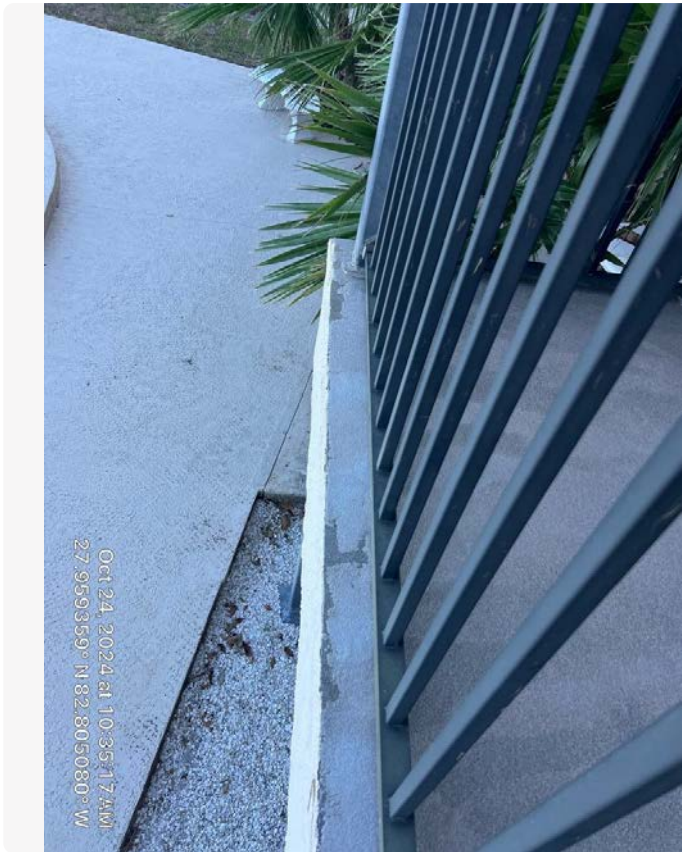
Deteriorating coatings observed on Unit 8 balcony slab edge.

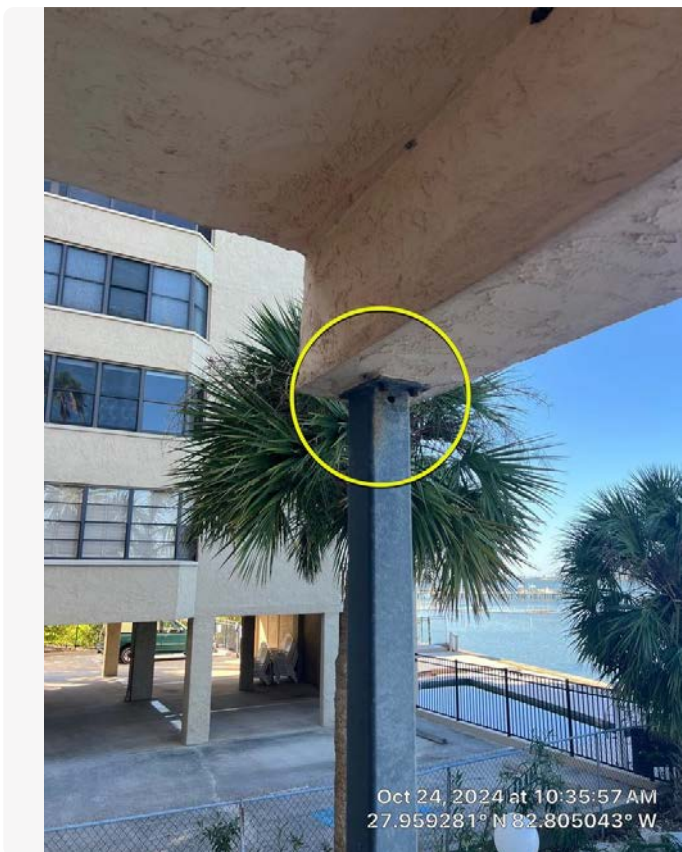
Minor corrosion observed on metal support column. Balcony of Unit 8. Right now this is minor surface rusting, however the steel needs to be repainted to help prevent further corrosion induced deterioration of the post.

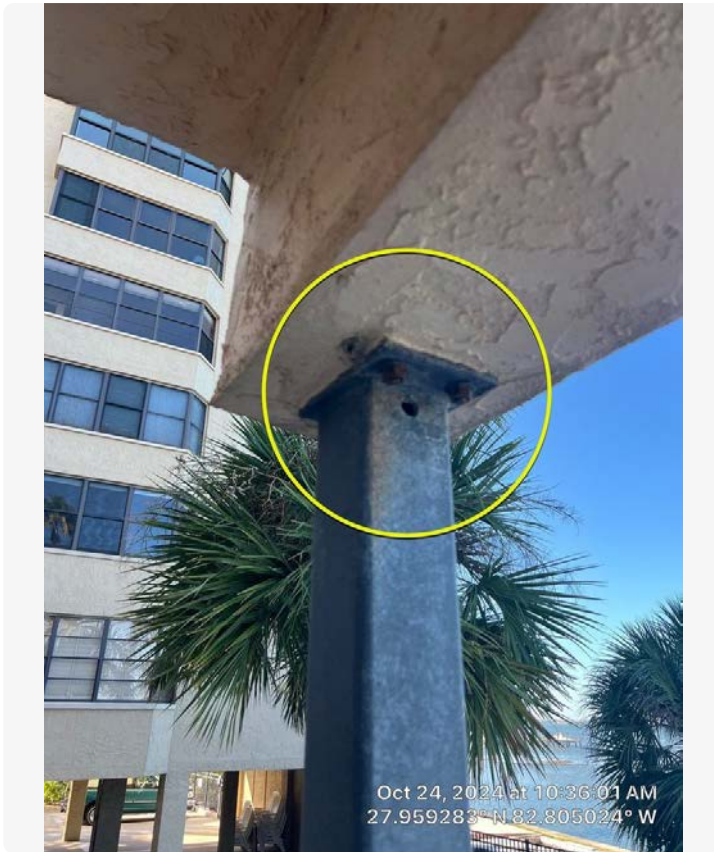
Minor corrosion observed on supports for balcony Unit 8. Right now this is minor surface rusting, however the steel needs to be repainted to help prevent further corrosion induced deterioration of the post.

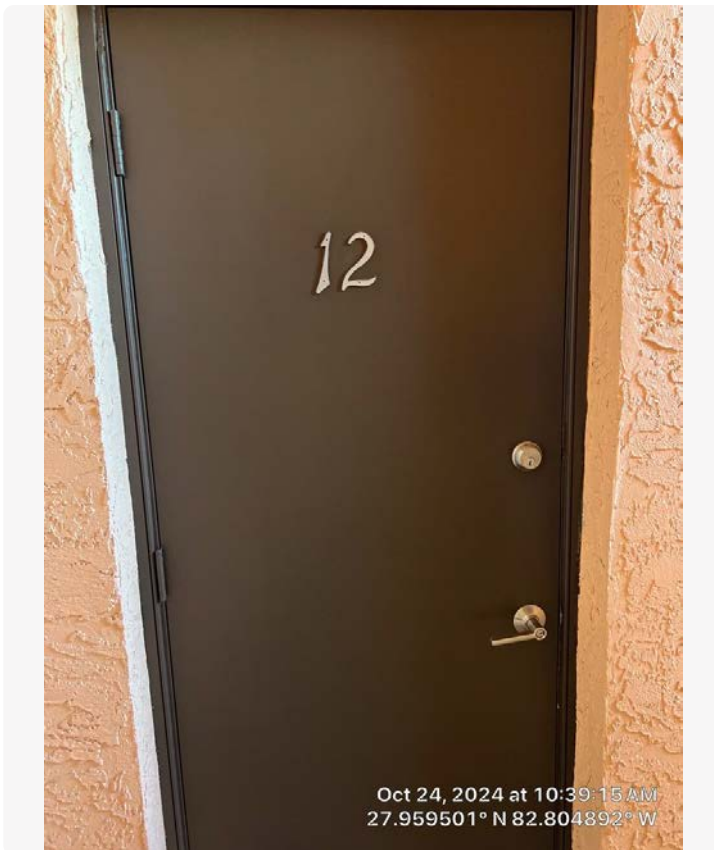
Project: Hickory Grove, Plus Attached Property
Date: 10/24/2024, 10:36am
Creator: Field Tech #1

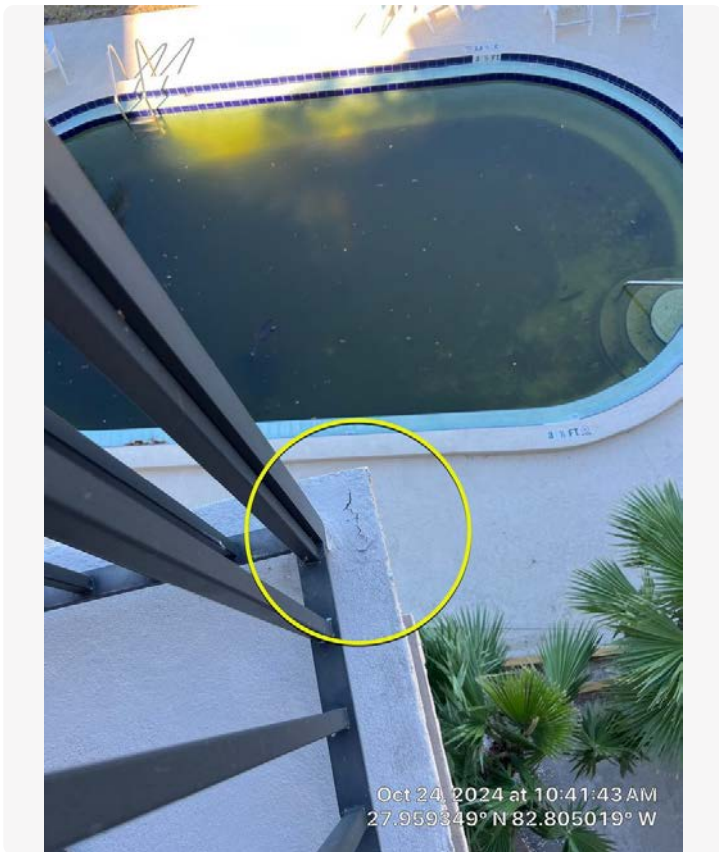
Minor cracks observed on the southwestern corner of balcony Unit 12. The coatings on the deck appear to generally be in good condition, however this slab edge should be touched up to prevent water intrusion.

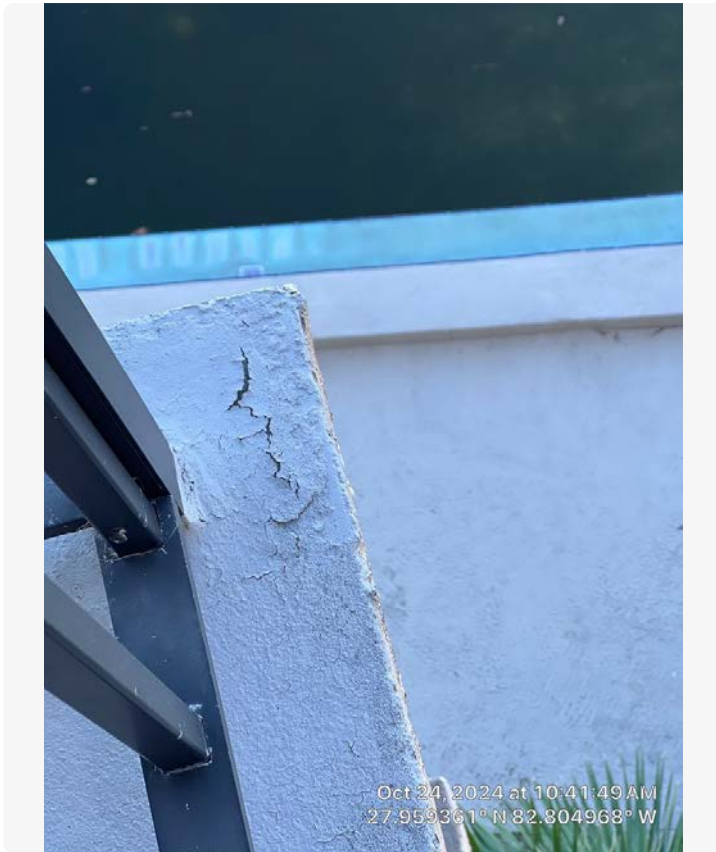
Minor cracks observed on the southwestern corner of balcony Unit 12. The coatings on the deck appear to generally be in good condition, however this slab edge should be touched up to prevent water intrusion.

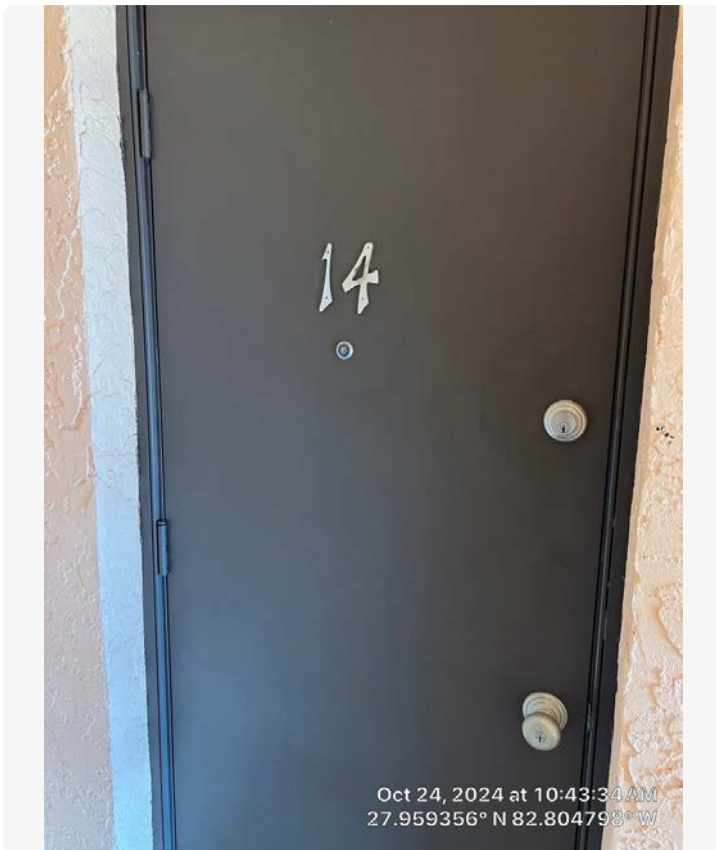
Project: Hickory Grove, Plus Attached Property
Date: 10/24/2024, 10:41am
Creator: Field Tech #1

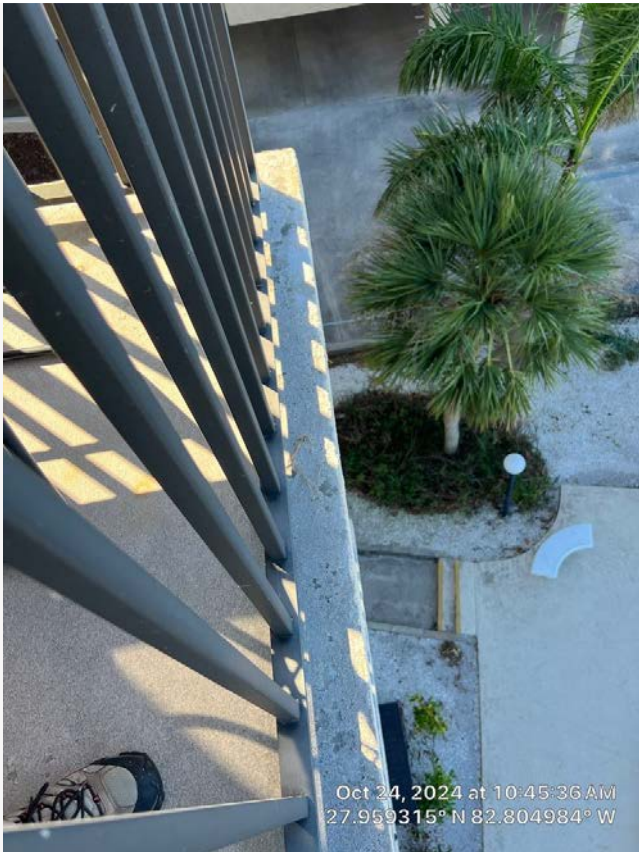
Deteriorating coatings observed on balcony slab edge Unit 14.

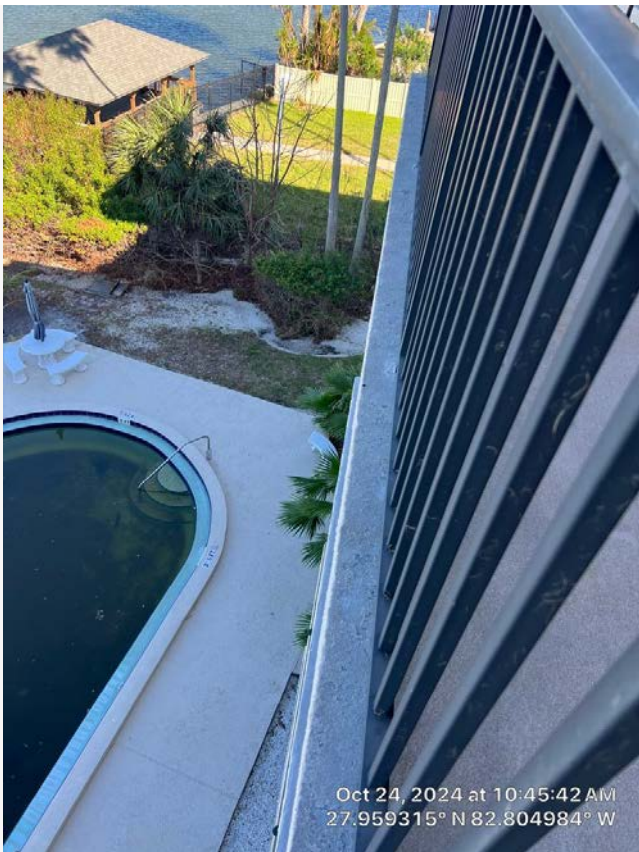
Balcony slab edge Unit 14.

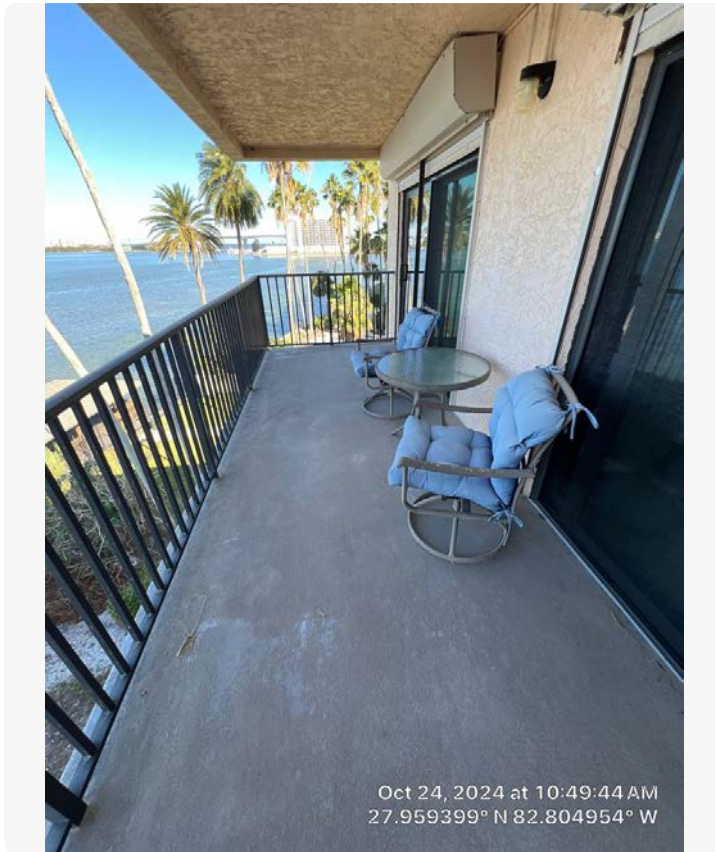
Balcony view Unit 13. Waterproof coatings on the deck are deteriorating and need to be recoated.

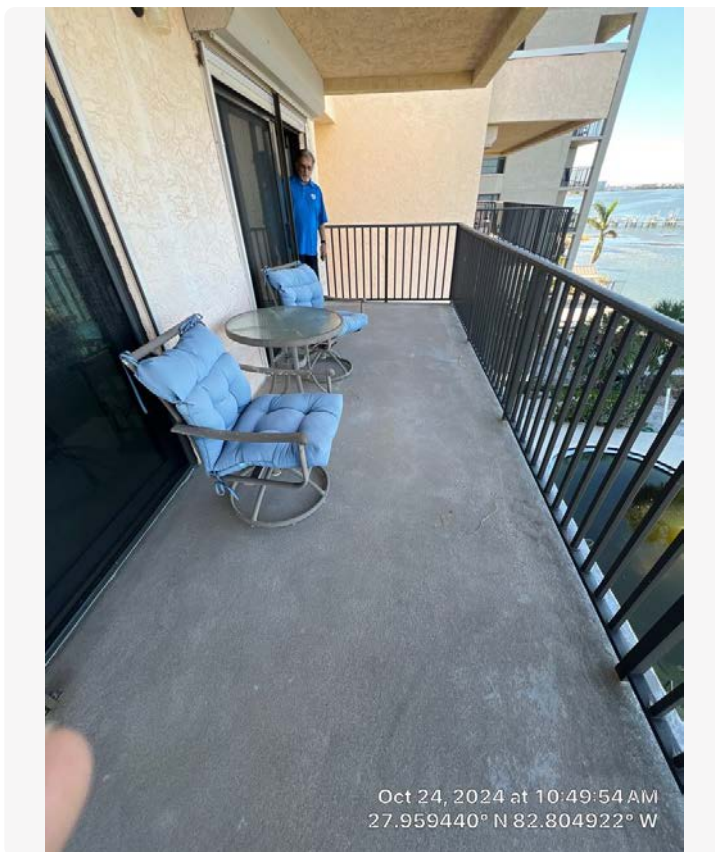
Alternate balcony view Unit 13.

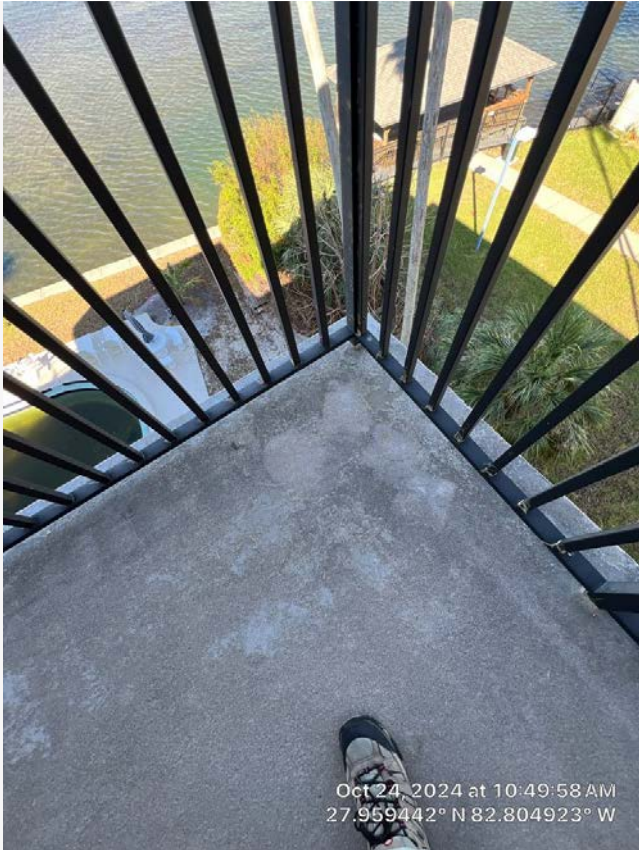
Balcony coatings of Unit 13 are deteriorating and will need to be repaired at some point.

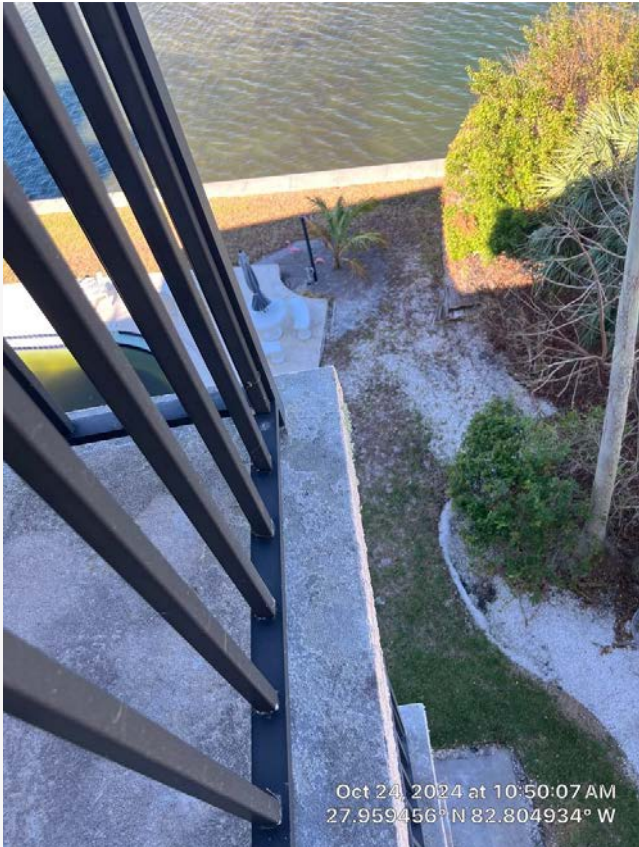
Northwest elevation of Unit 13 balcony.

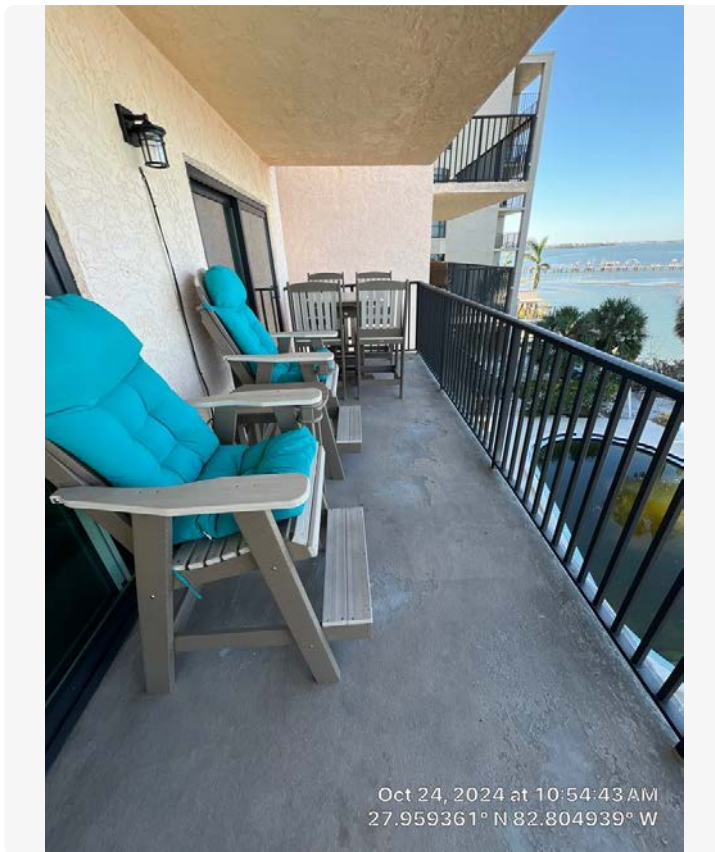
Balcony view of Unit 11. The deck waterproofing needs to be removed and replaced, as it has reached the end of its useful life.

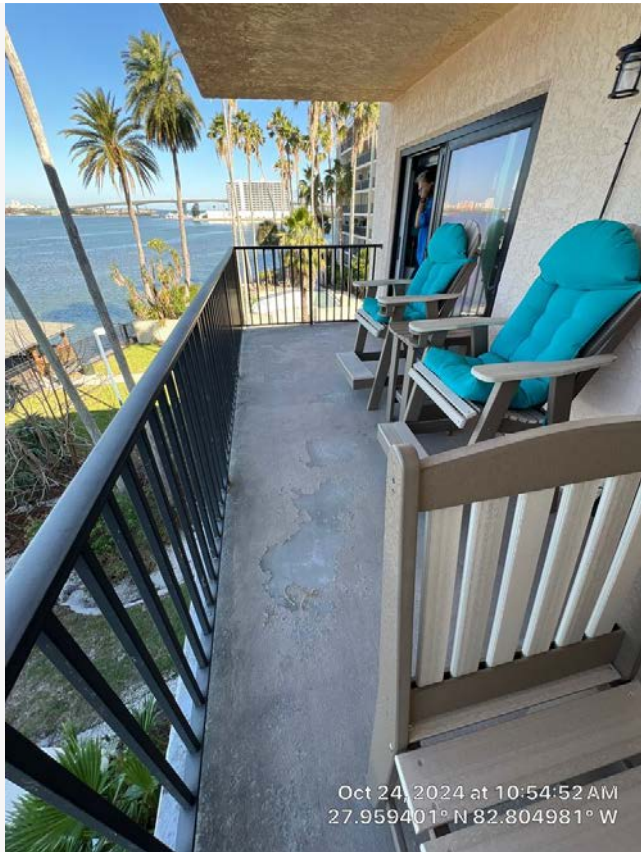
Alternate balcony view of Unit 11.

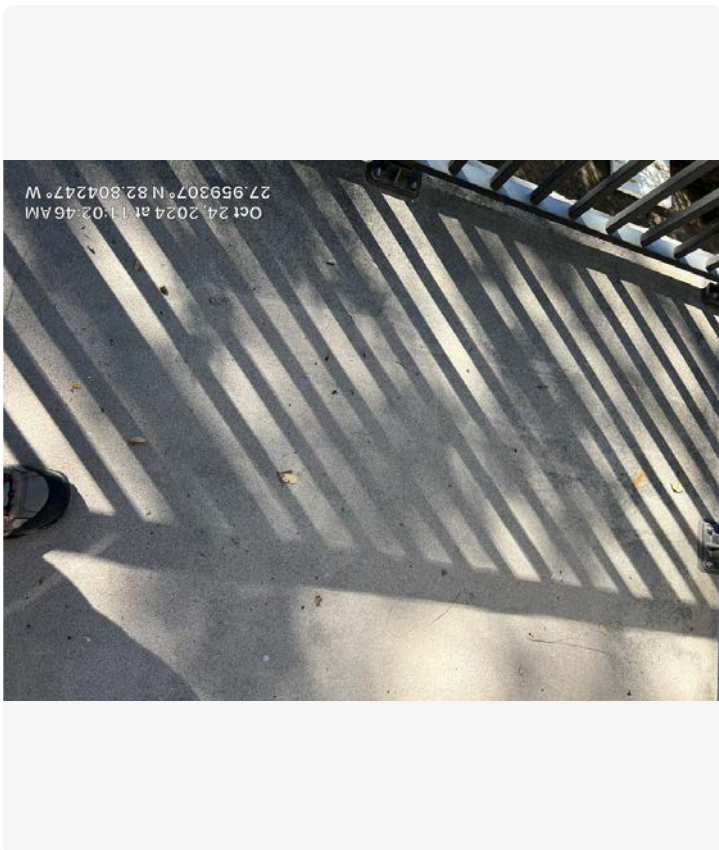
Unit 2 south balcony, Typical conditions observed throughout the building.

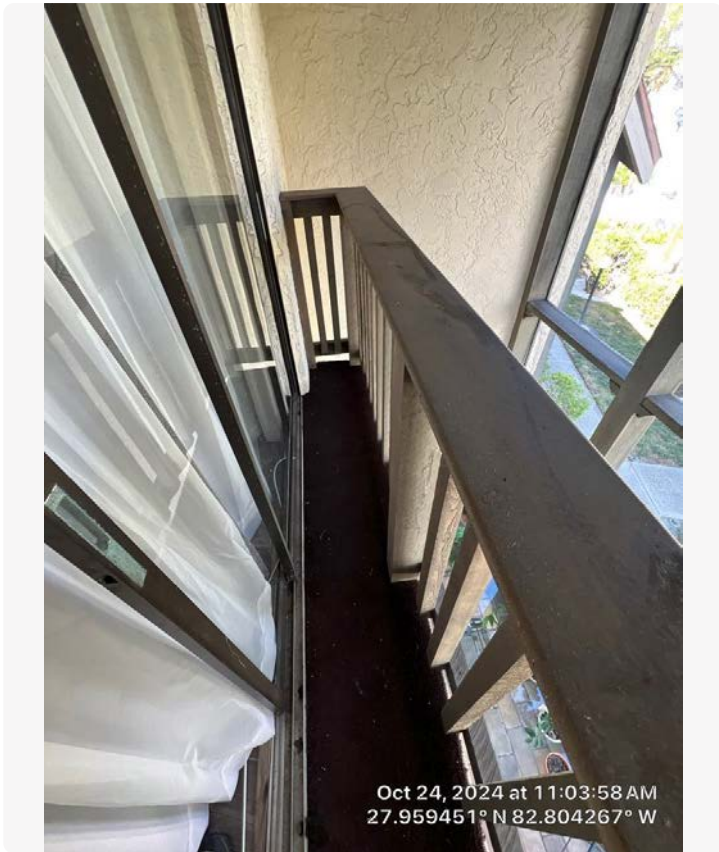
Unit 2 north balcony.

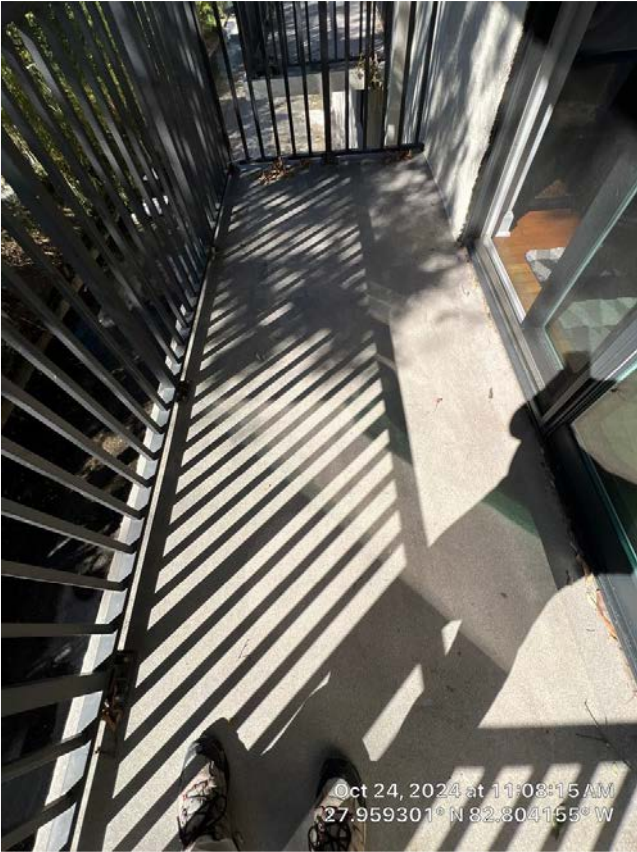
Unit 1 balcony general conditions.

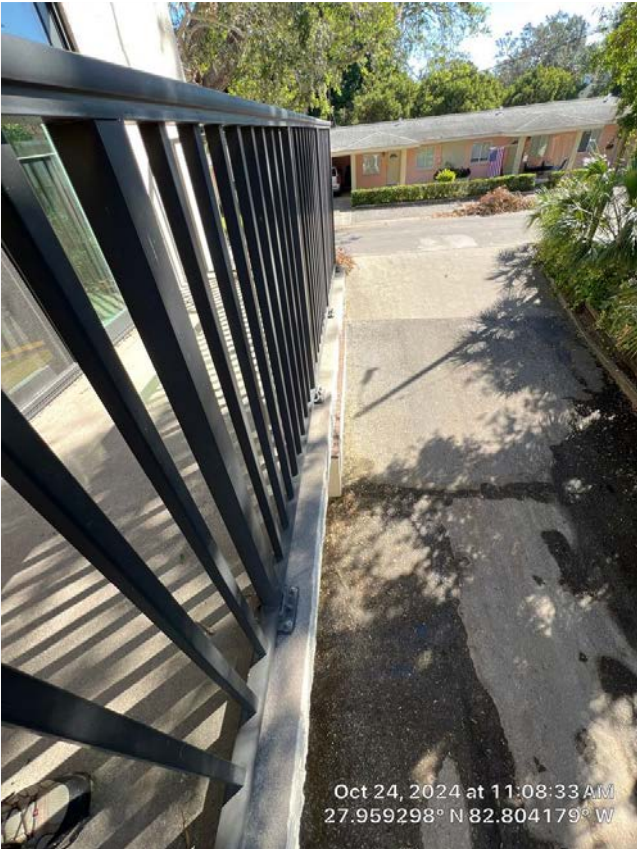
Unit 1 balcony slab edge.

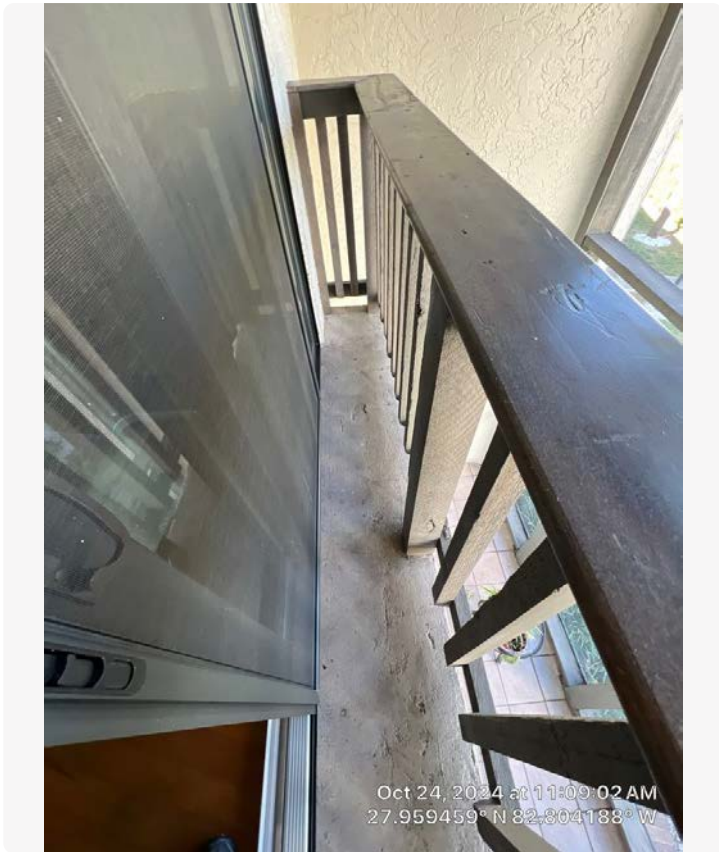
Unit 1 north balcony. Bare concrete balcony observed.

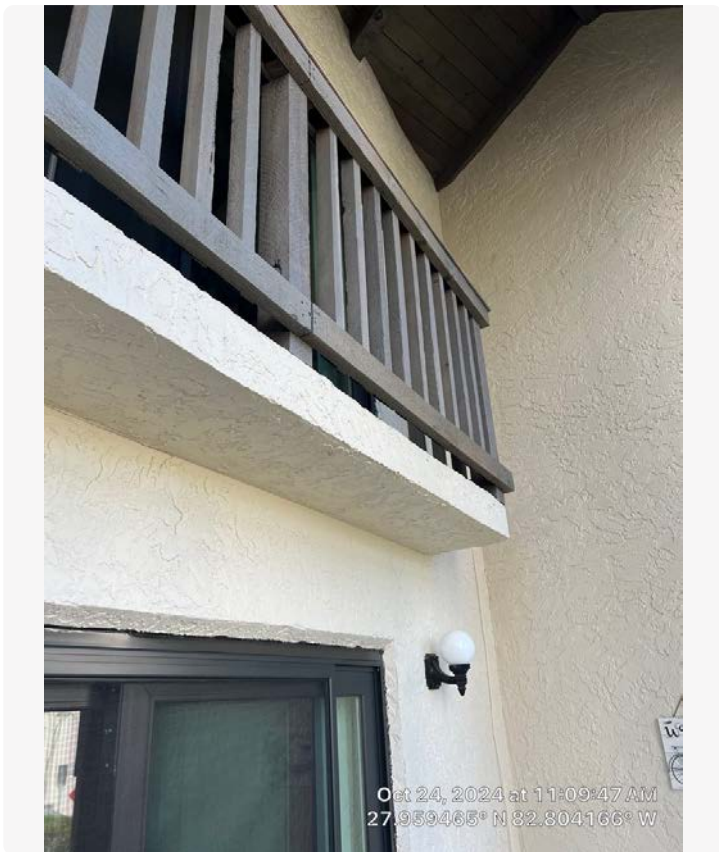
Unit 1 north balcony slab edge.

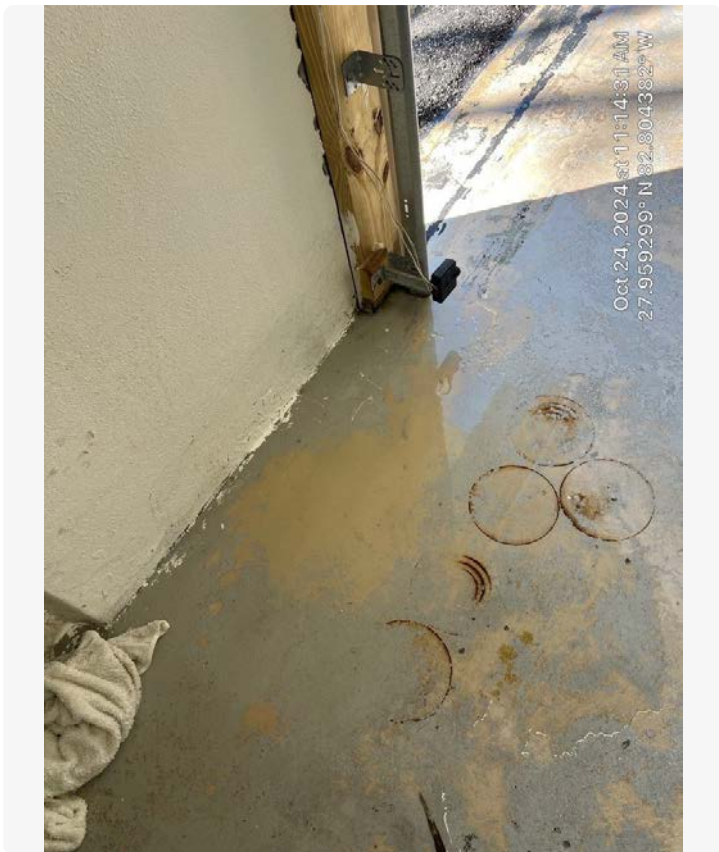
Water observed on floor of garage entrance Unit 3.

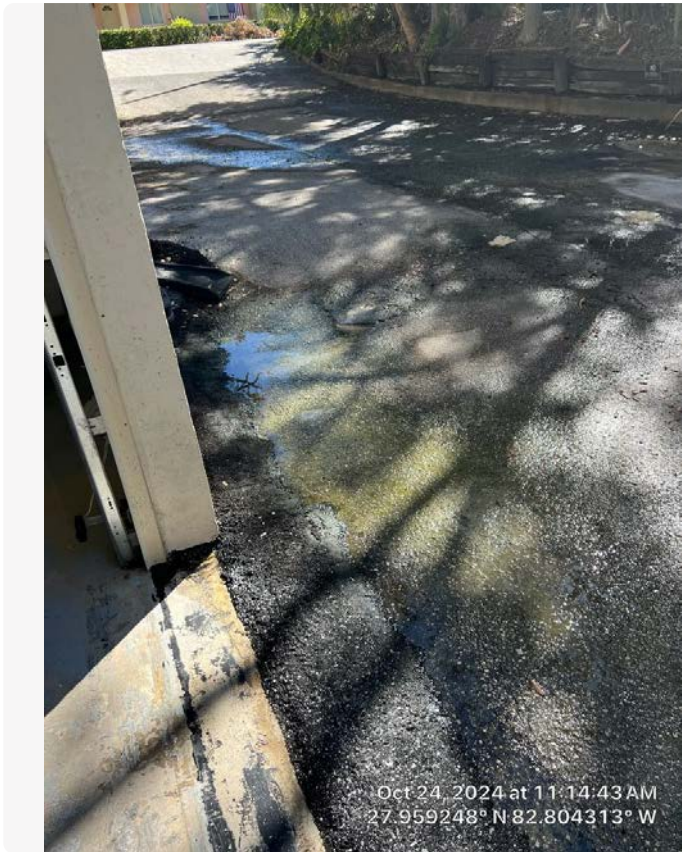
Outside of Unit 3. This water is reported to be from some unknown source other than rain. The source is unknown.

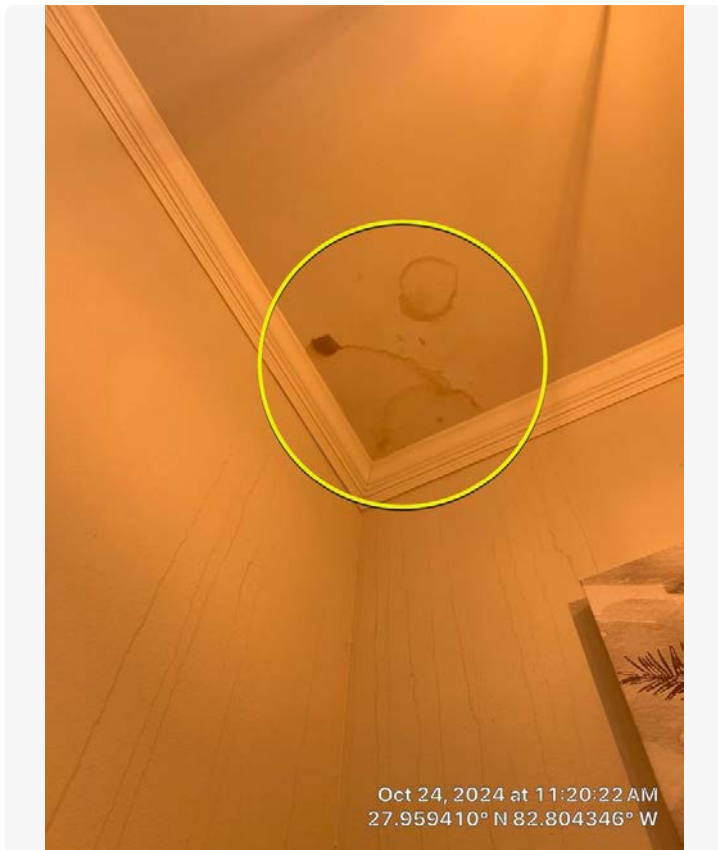
Water leak observed at 1st floor of Unit 4 interior.

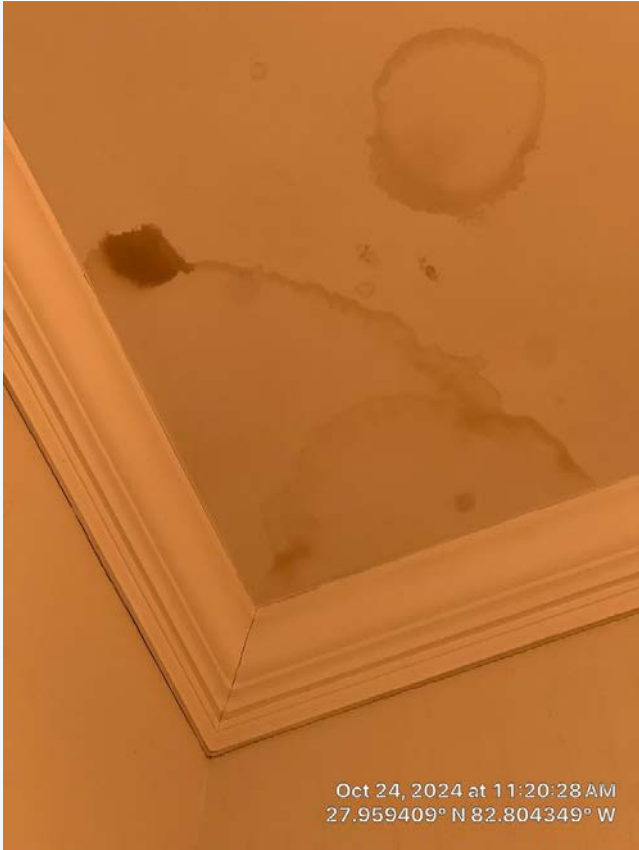
Water leak observed at 1st floor of Unit 4 interior.

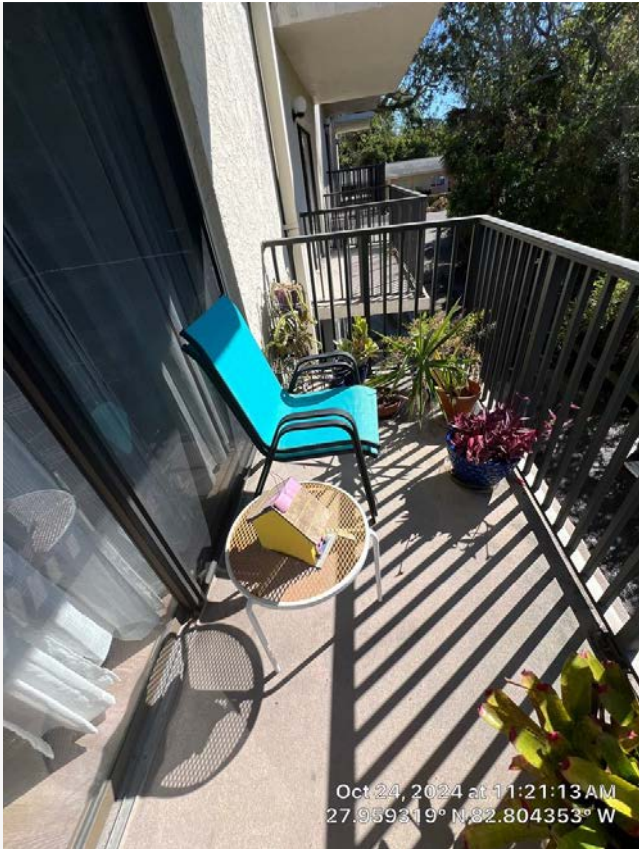
South balcony of Unit 4.
