MATERIAL FINDINGS AND RECOMMENDATIONS:

INSPECTOR SUMMARY OF MILESTONE PHASE 1 INSPECTION

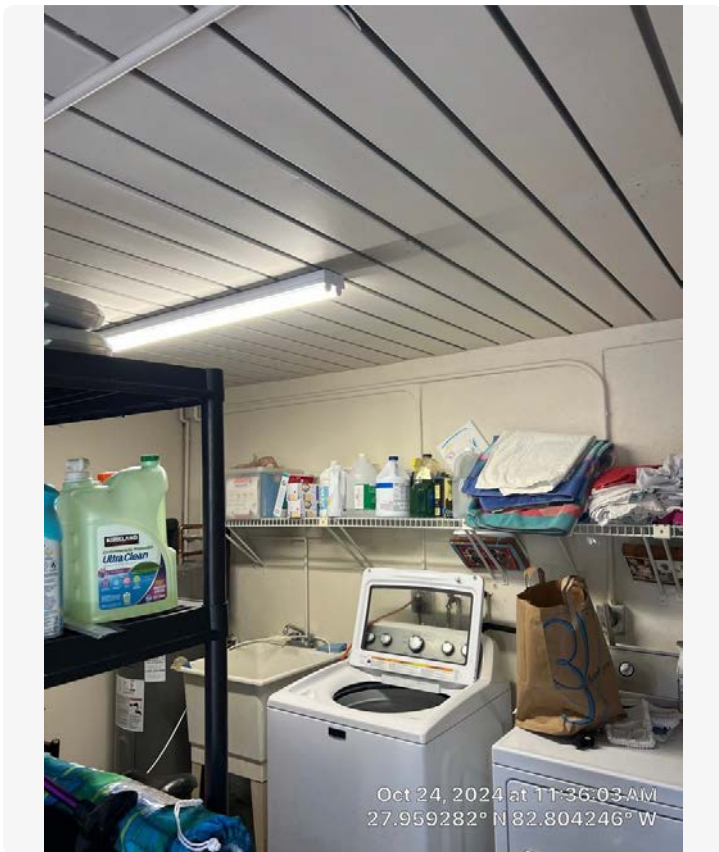
Unit 2 garage. Typical of conditions observed throughout the garages of this building.

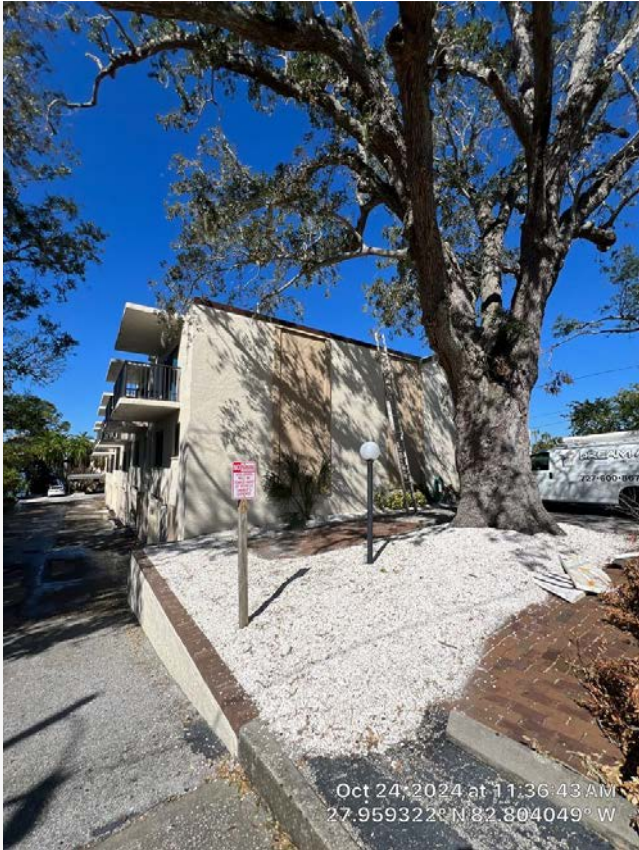
Side (east) elevation.

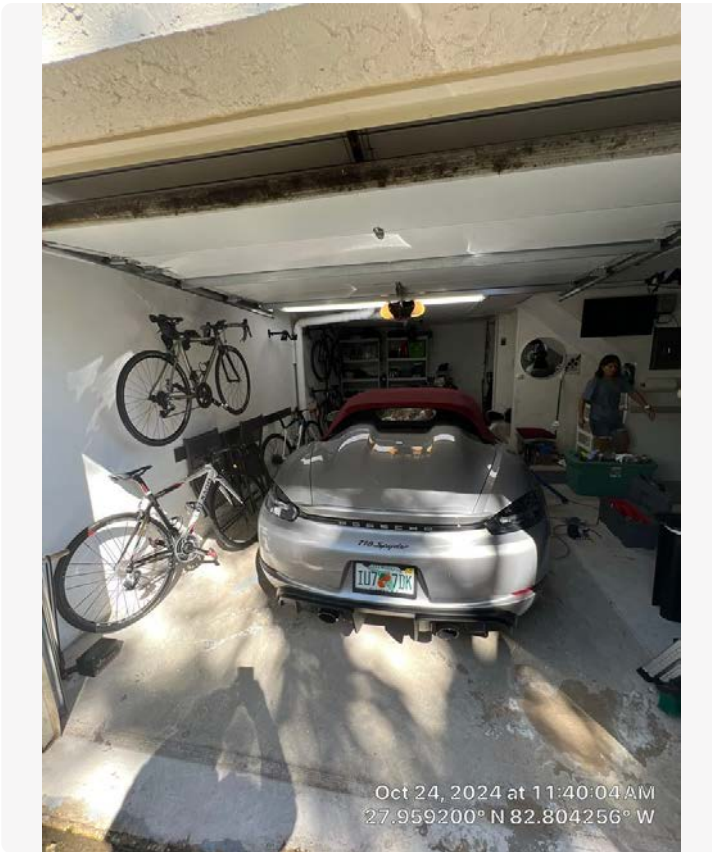
Unit 1 garage. Typical conditions observed throughout garages in this building.

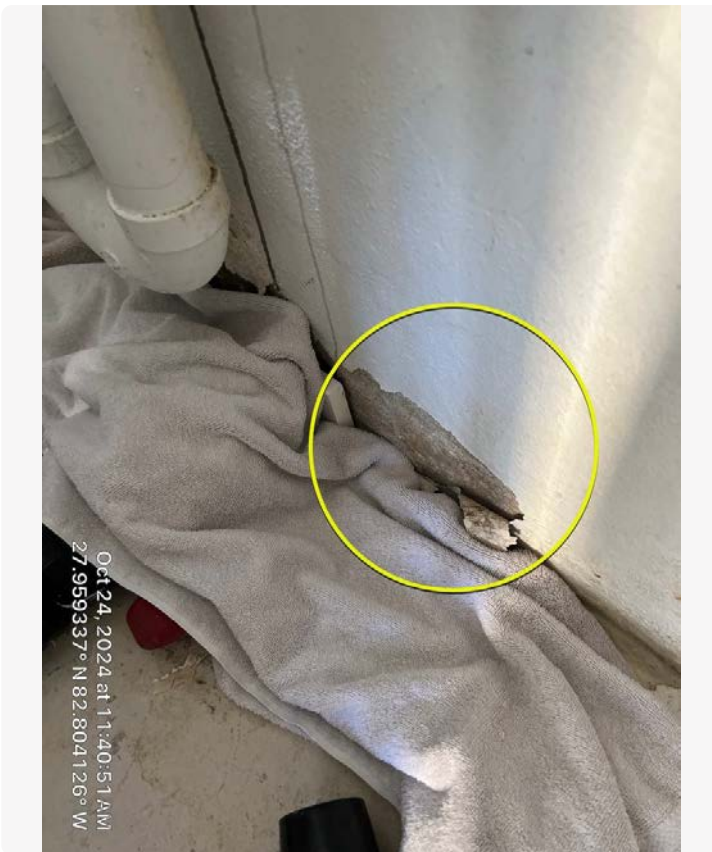
Unit 1 garage. Small leak. Owner estimates a gallon per hour during storm.

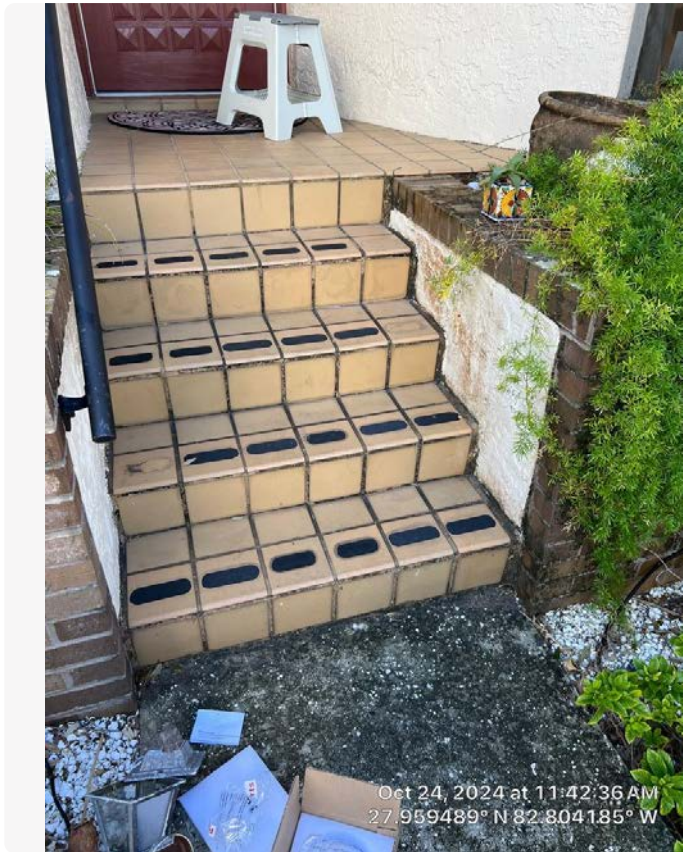
Stairs to front door Unit 2

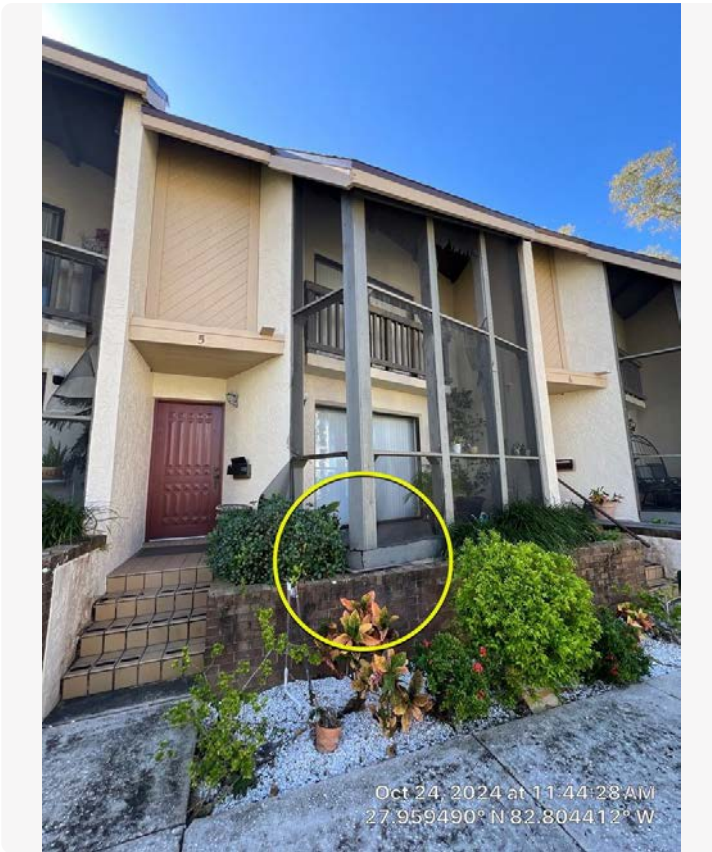
Unit 5 porch enclosure. Damage to wooden posts observed at this location.

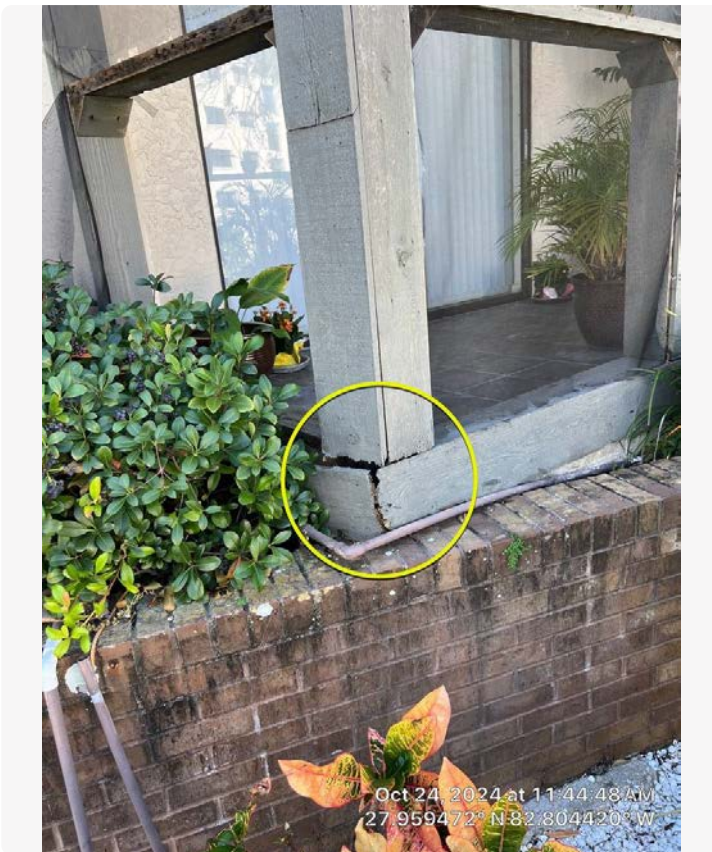
Unit 5 porch enclosure. Damage to wooden posts observed at this location.

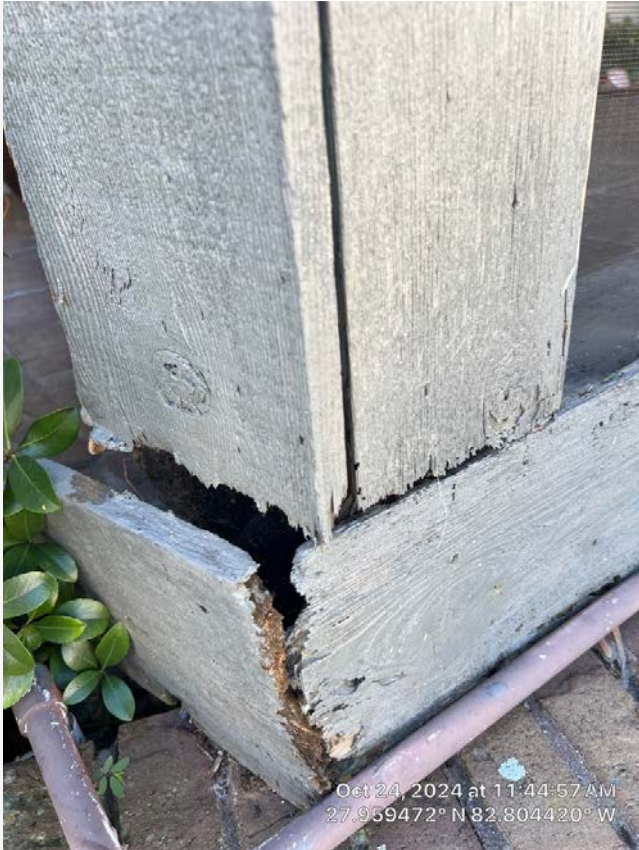
Unit 5 porch enclosure. Damage to wooden posts observed at this location.

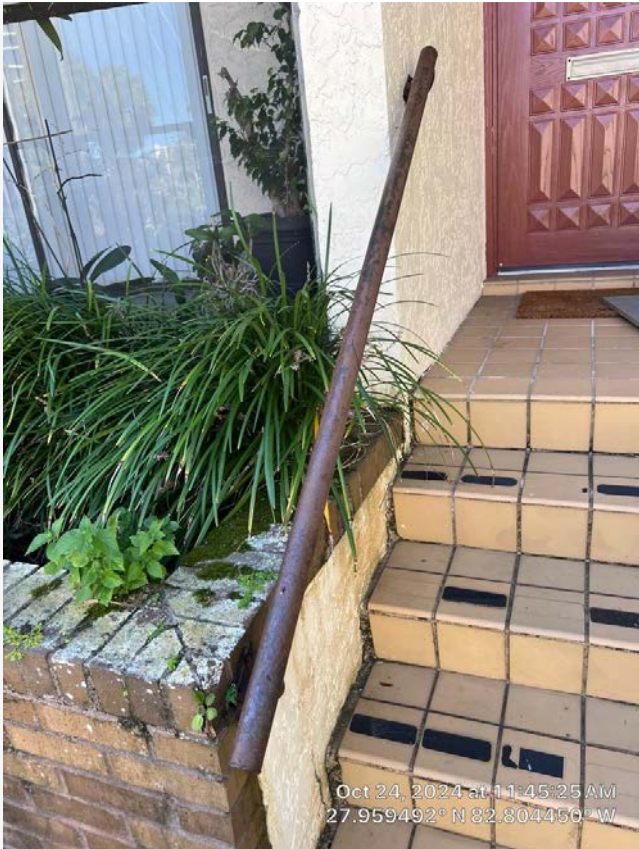
Corrosion observed on handrail of Unit 6. North (front) elevation.

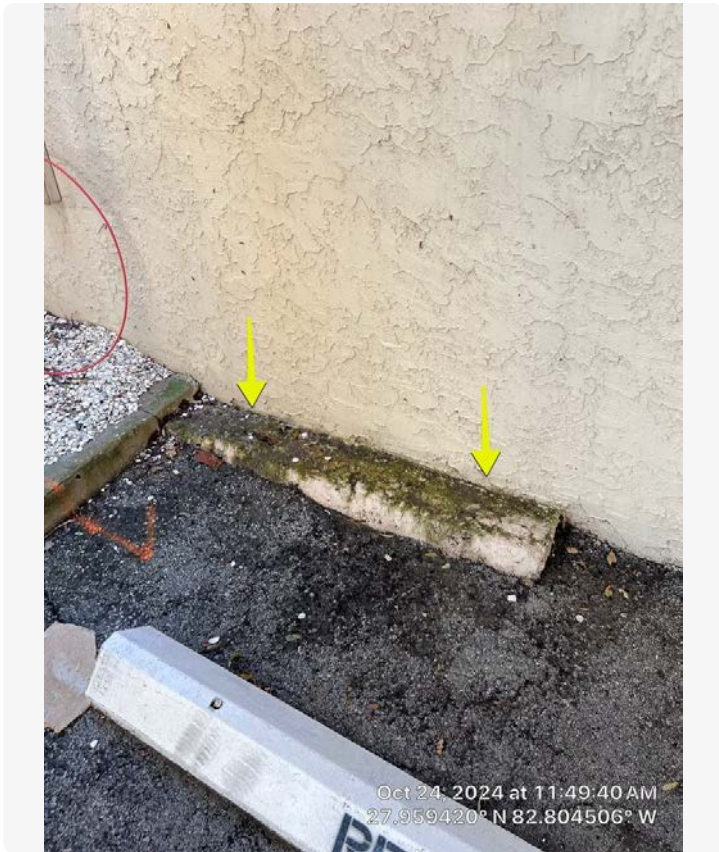
Northern corner of the west building elevation. Indications of water accumulation at base of building.

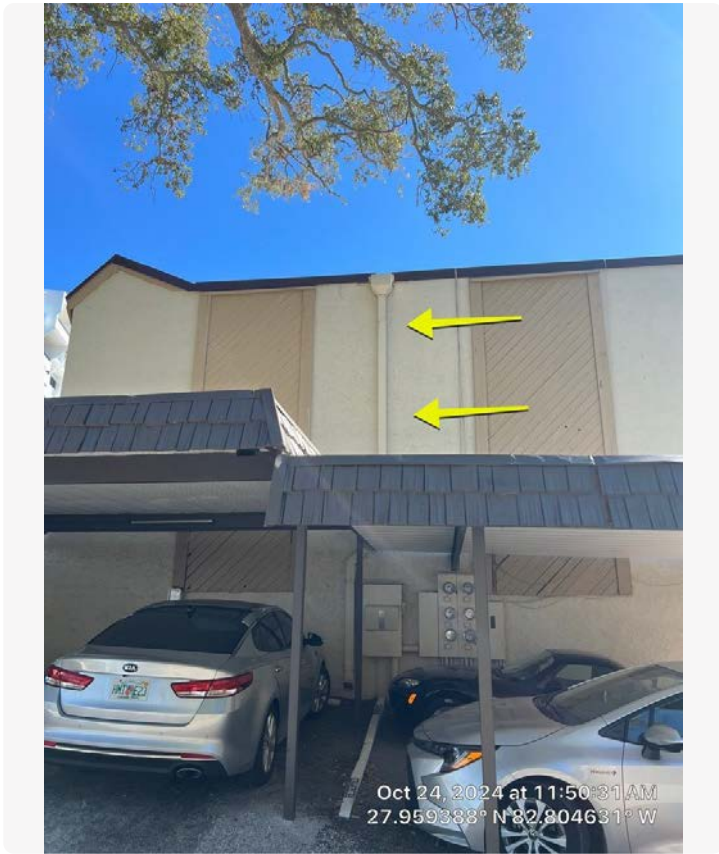
West elevation near downspout. Uneven stucco application or possible previous repair.

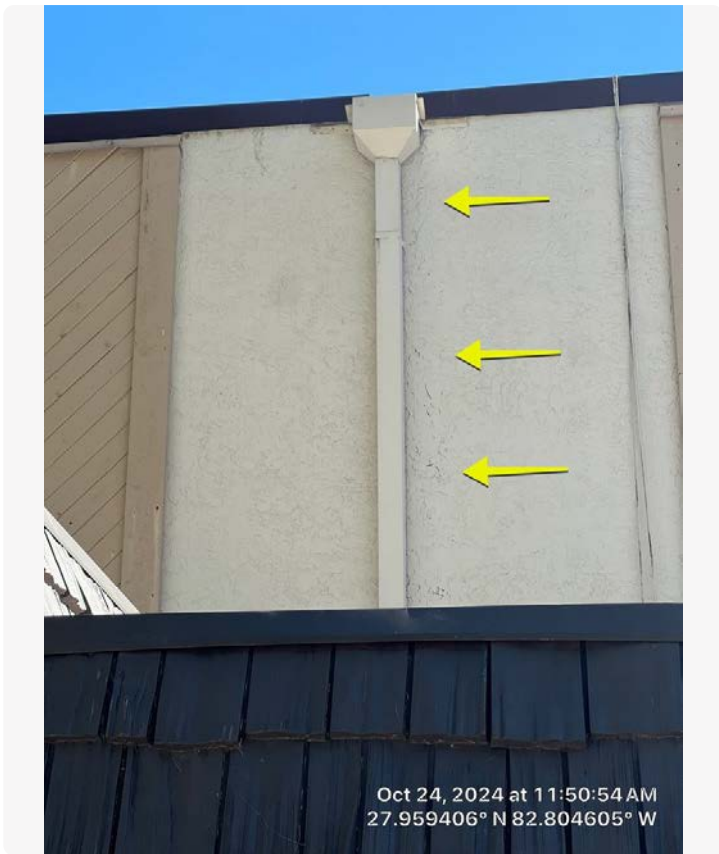
West elevation near downspout. Uneven stucco application or possible previous repair.

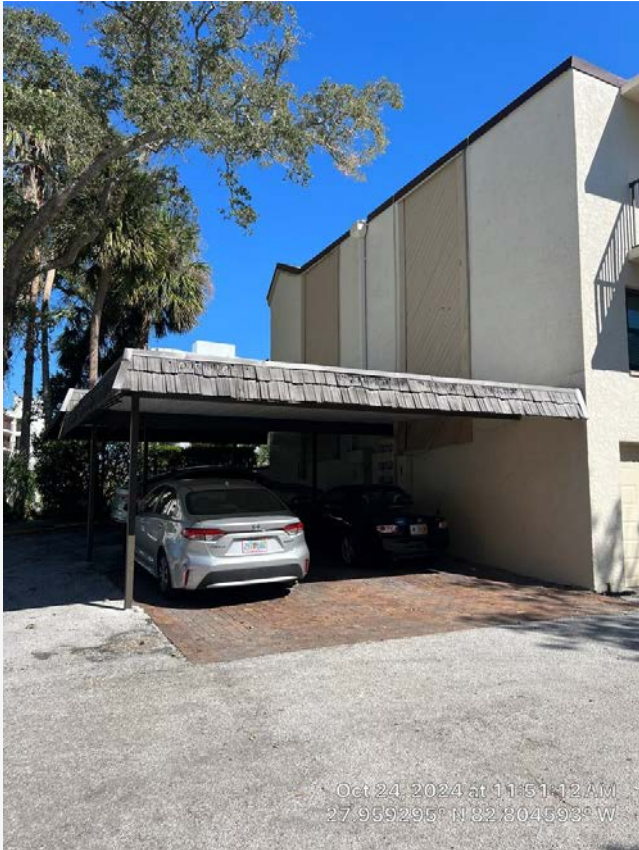
Carport west elevation.

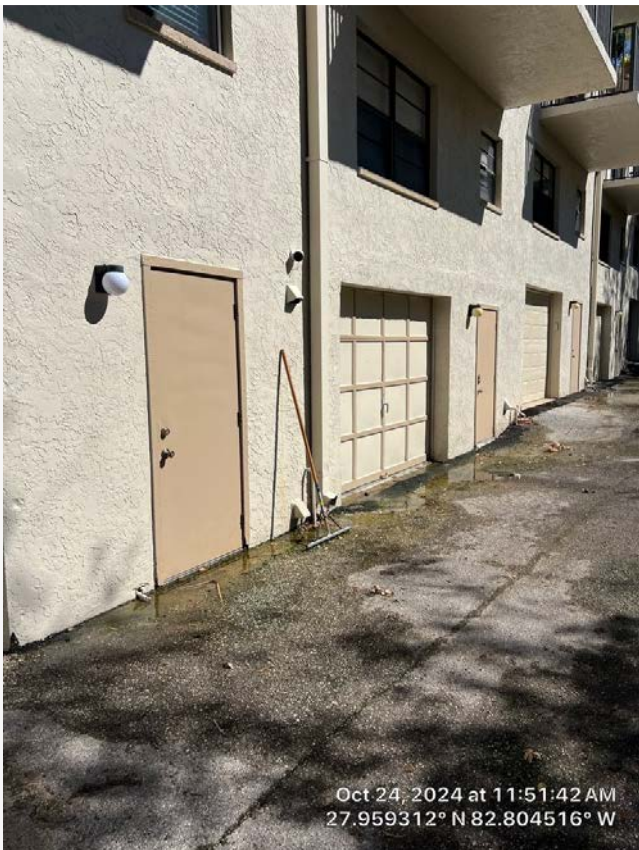
South elevation. Units 5 and 6 garage area. Water noted pooling.

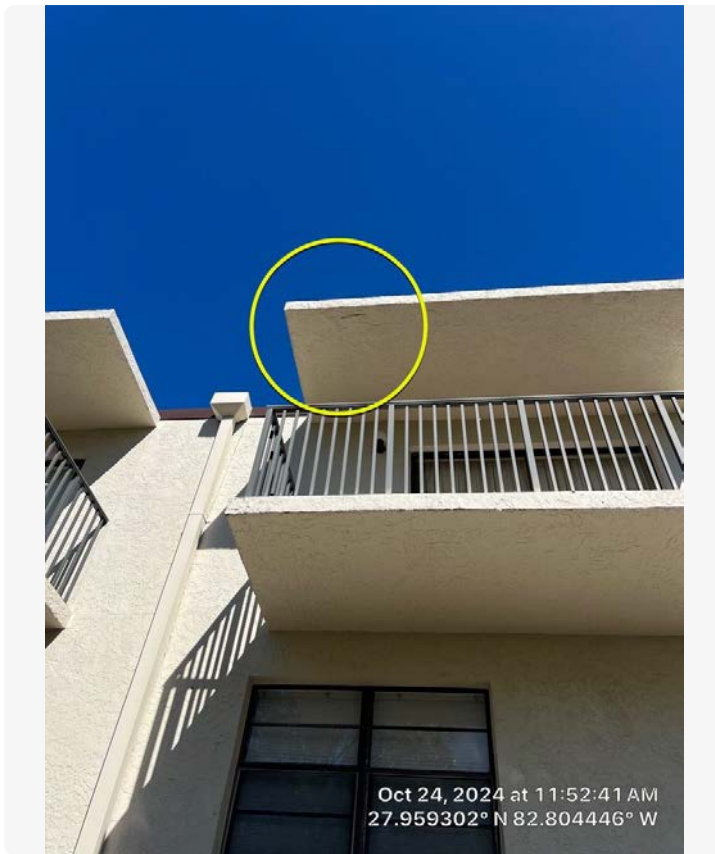
Unit 5 upper balcony roof. Possible water intrusion and stucco delamination. (South rear elevation)

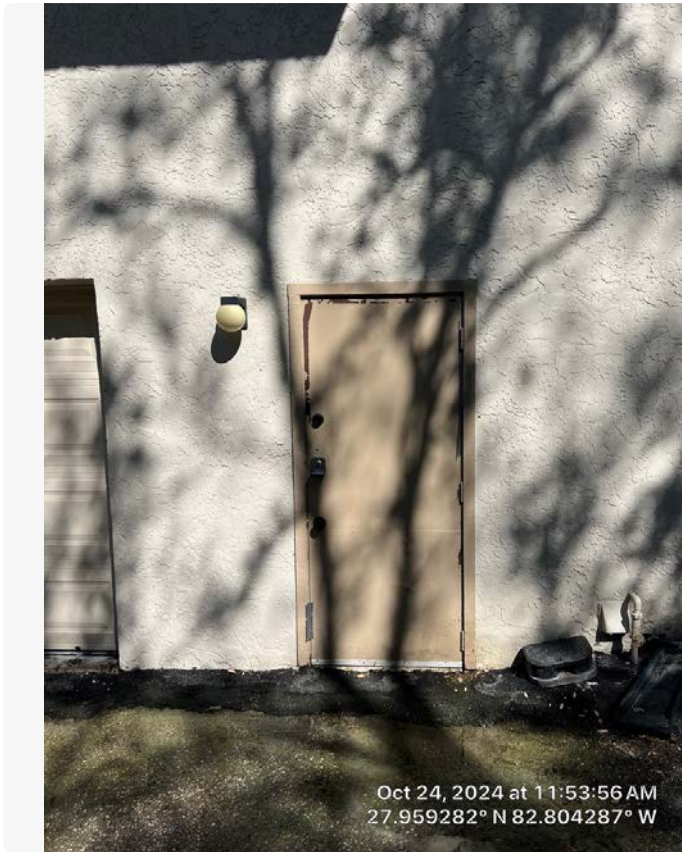
Unit 3 garage door corrosion noted.

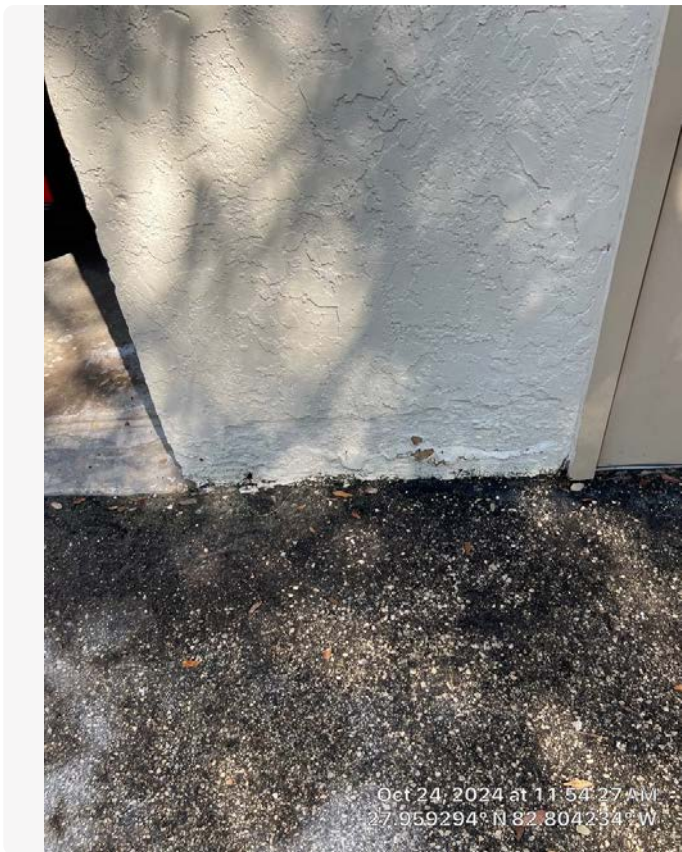
Garage unit 2. Water damage to stucco noted.

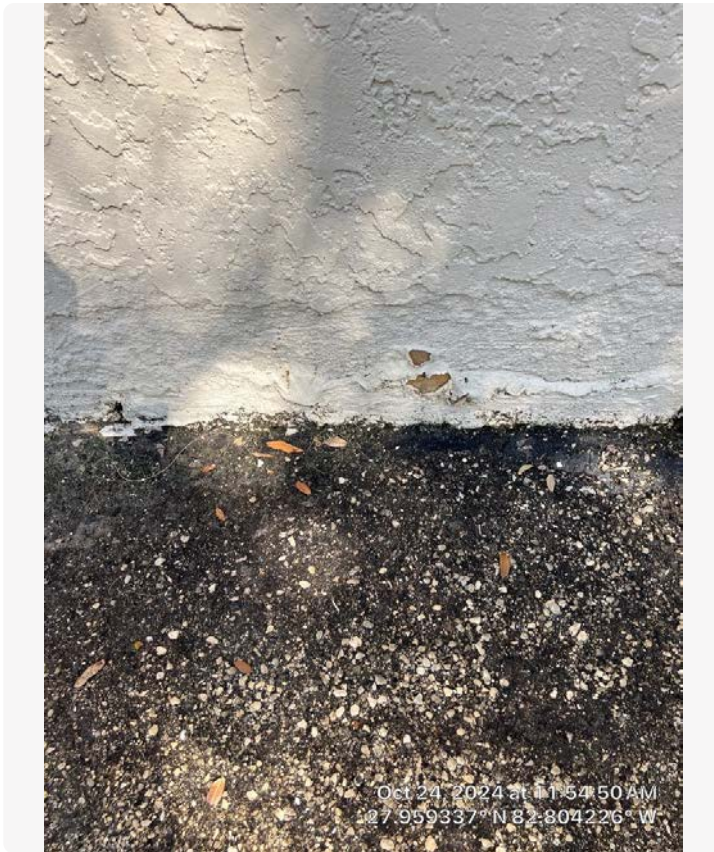
Garage unit 2. Water damage to stucco noted.

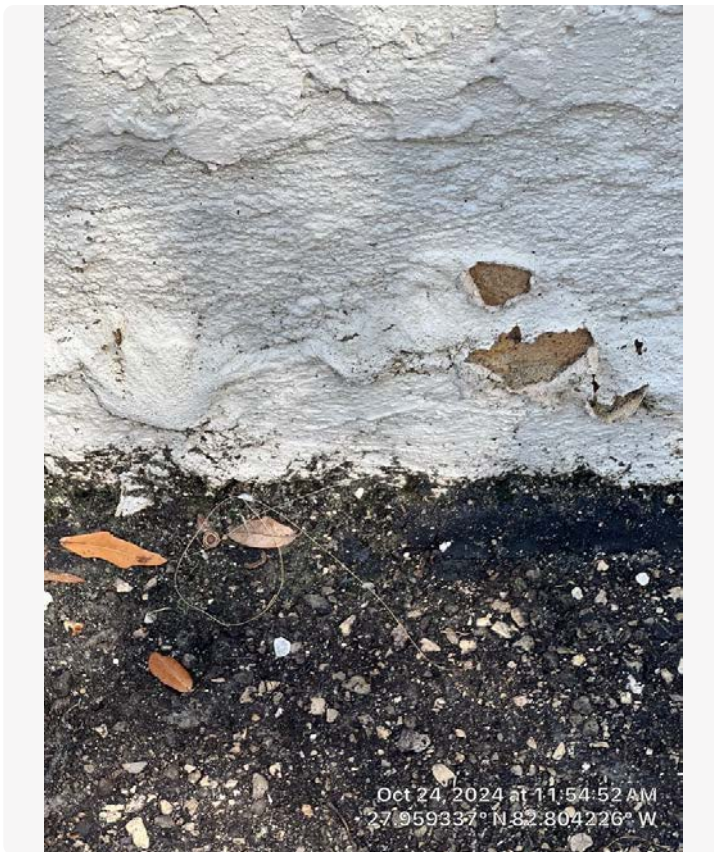
Garage unit 2. Water damage to stucco noted.
