COMMERCIAL WINDSTORM MITIGATION REPORT (OIR-B1-1802)

Hickory Grove Condominium Association, Inc.

9 Turner St, Units 7-14

As of 8/27/2018

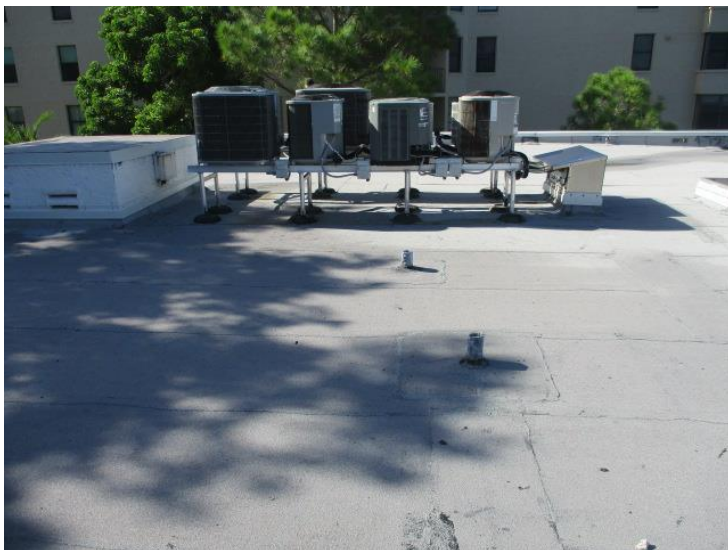
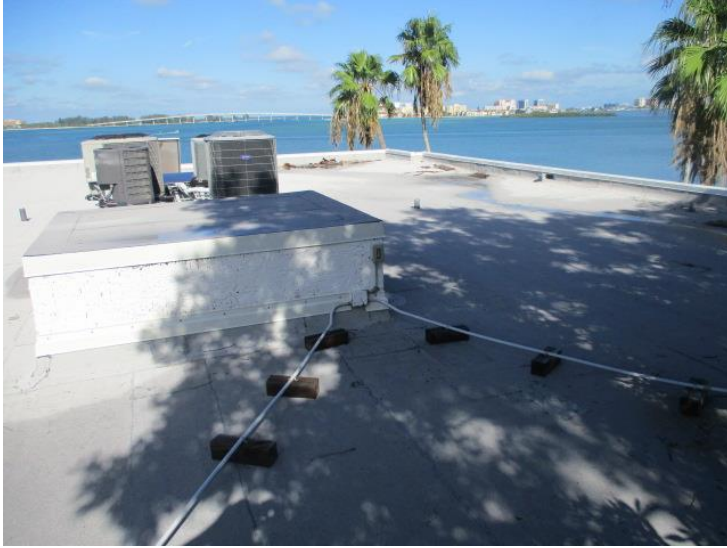
Roof Construction

3. **Roof Deck Attachment:** **Reinforced Concrete Roof Deck**
Comments: Inspection verified a roof structure composed of cast-in-place or pre-cast structural concrete designed to be self supporting and integrally attached to the wall / support system.

4. **Roof to Wall Attachment:** **Structural**
Comments: Inspection verified a roof structure composed of cast-in-place or pre-cast structural concrete designed to be self supporting and integrally attached to the wall / support system.

5. **Roof Geometry:** **Flat Roof**
Comments: Inspection verified flat roof shape, refer to attached photographs.
6. **SWR:** **No**
Comments: SWR does not apply to reinforced concrete roof decks.

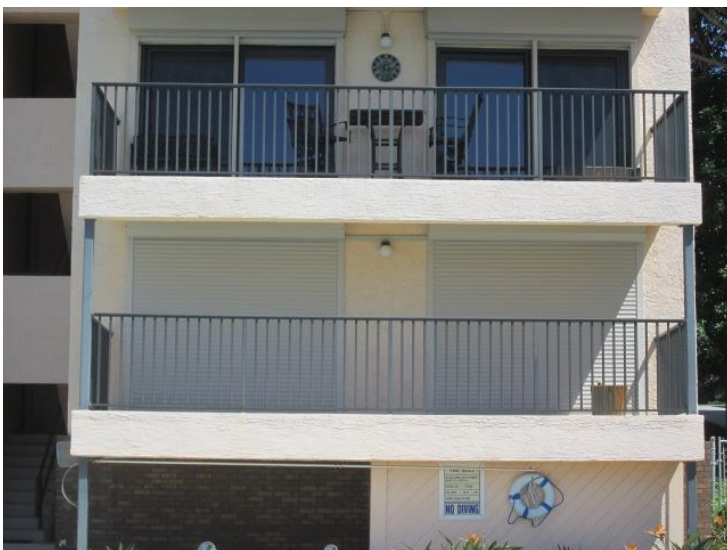
Opening Protection

7. **Opening Protection:** **None or Some Glazed Openings**
Comments: Inspection verified some metal shutter opening protection. Not all glazed openings were protected with impact resistant coverings.
